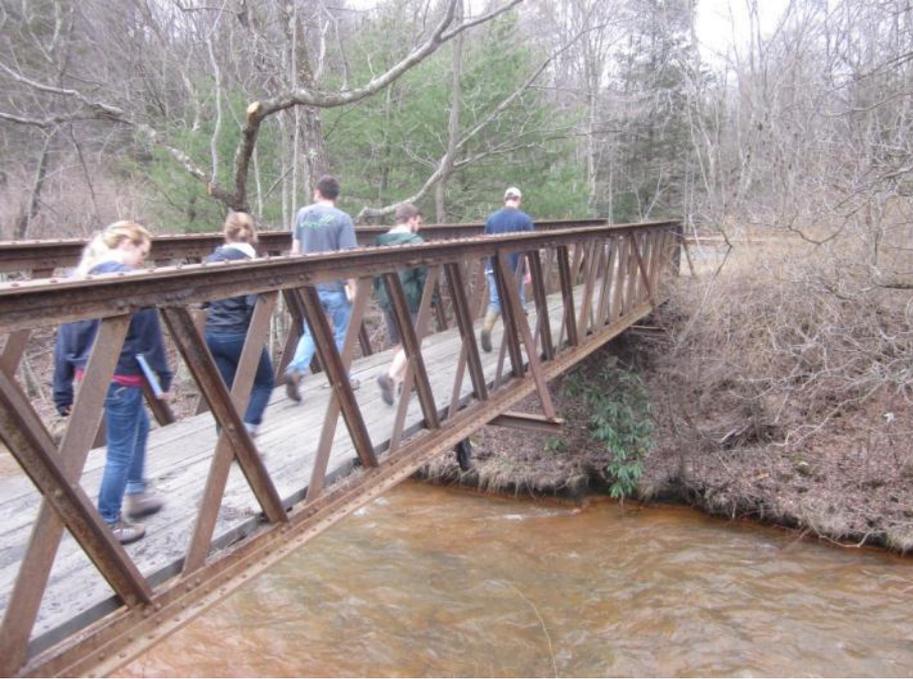
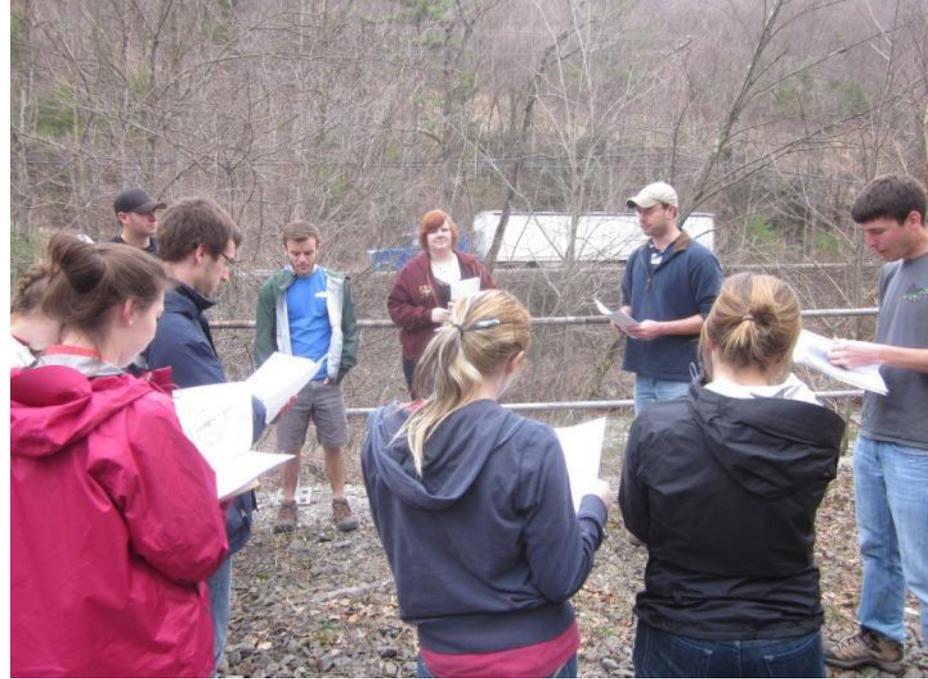
Stop #1 – The confluence of the West Branch and the West West Branch of the Schuylkill River. Wayne discussed the hydrology of the area in terms of watershed and the problem of lost water, transferred through underground mine workings.

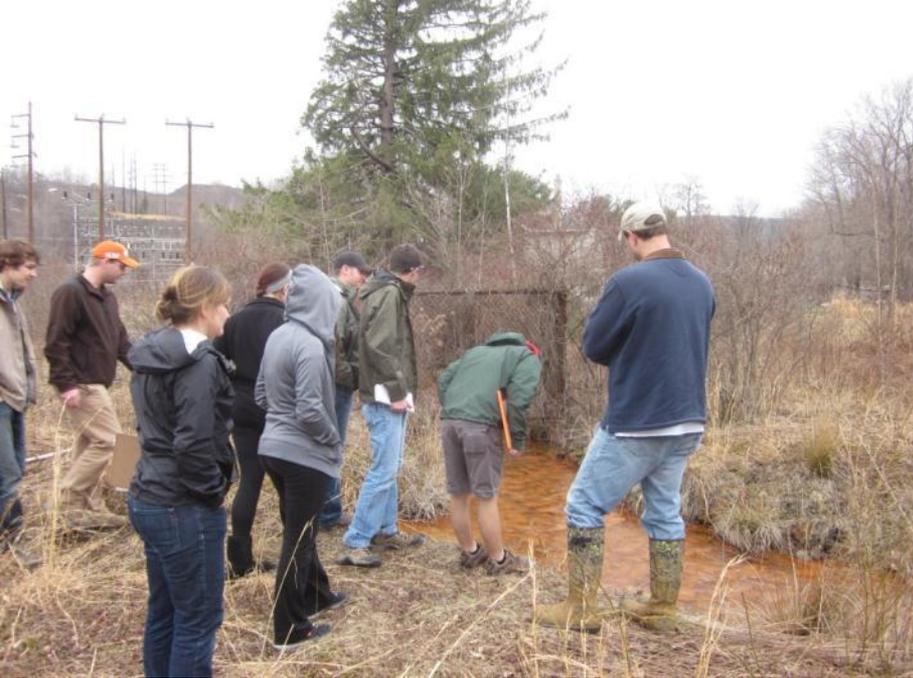
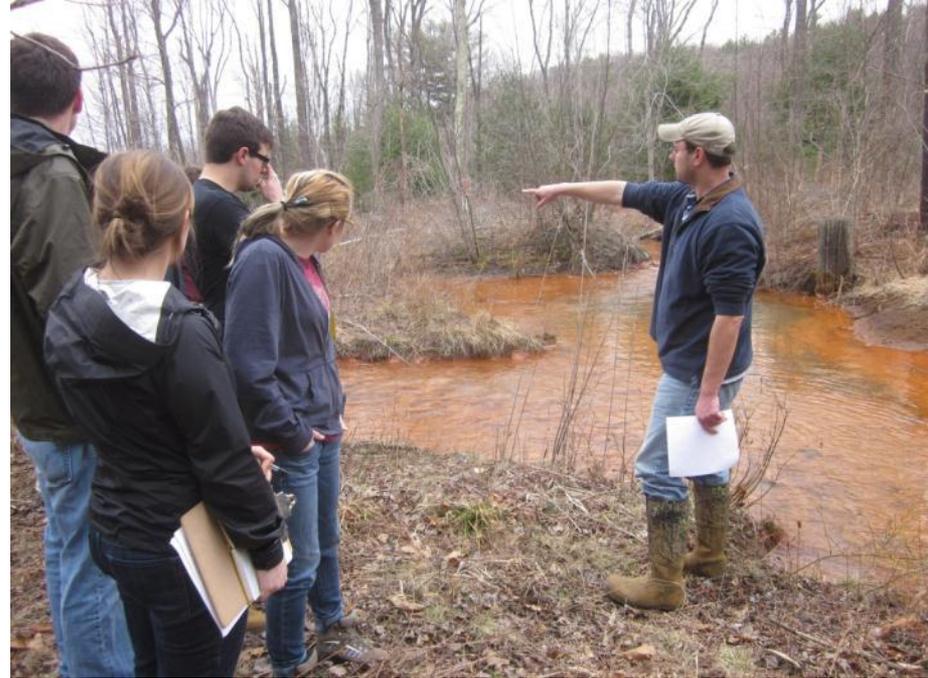
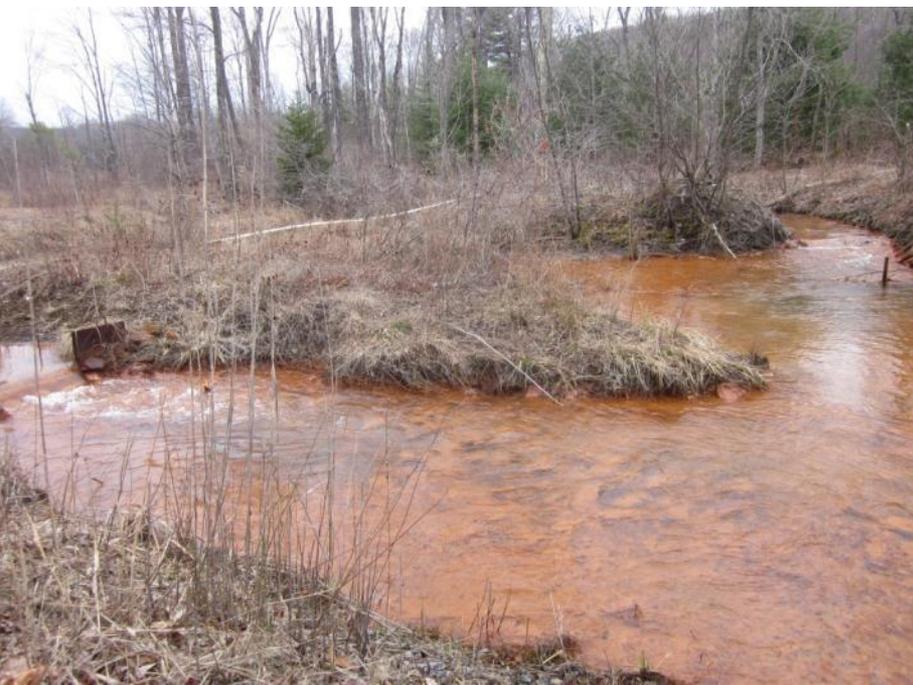
Stop #2 – The Oak Hills Boreholes. Water discharges from subsurface mines at this location. The discharge area frequently floods during high rains, thus making the area impractical for passive treatment of the water. This water discharges into the West Branch of the Schuylkill River.

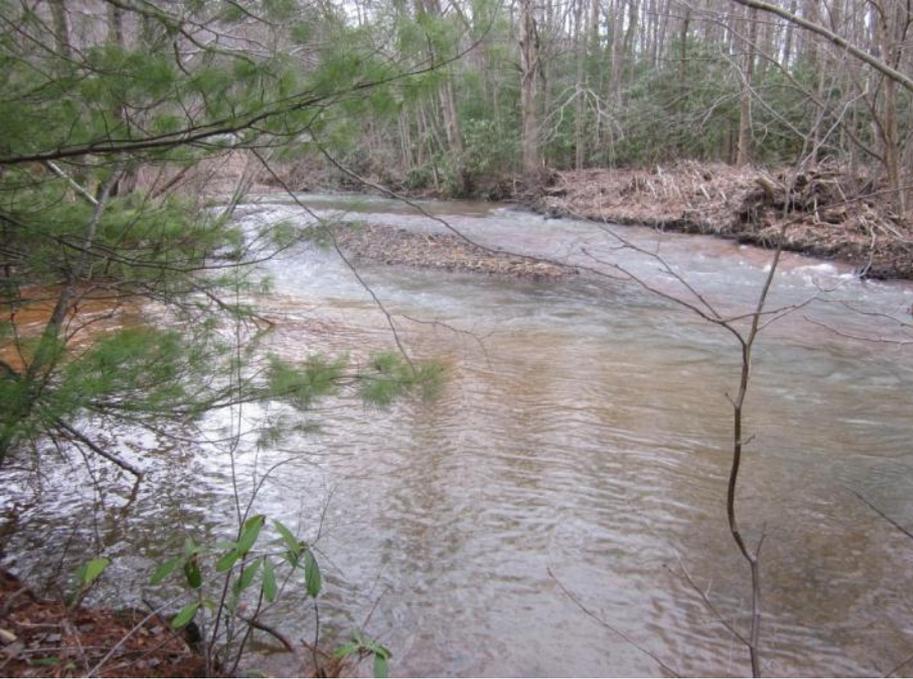
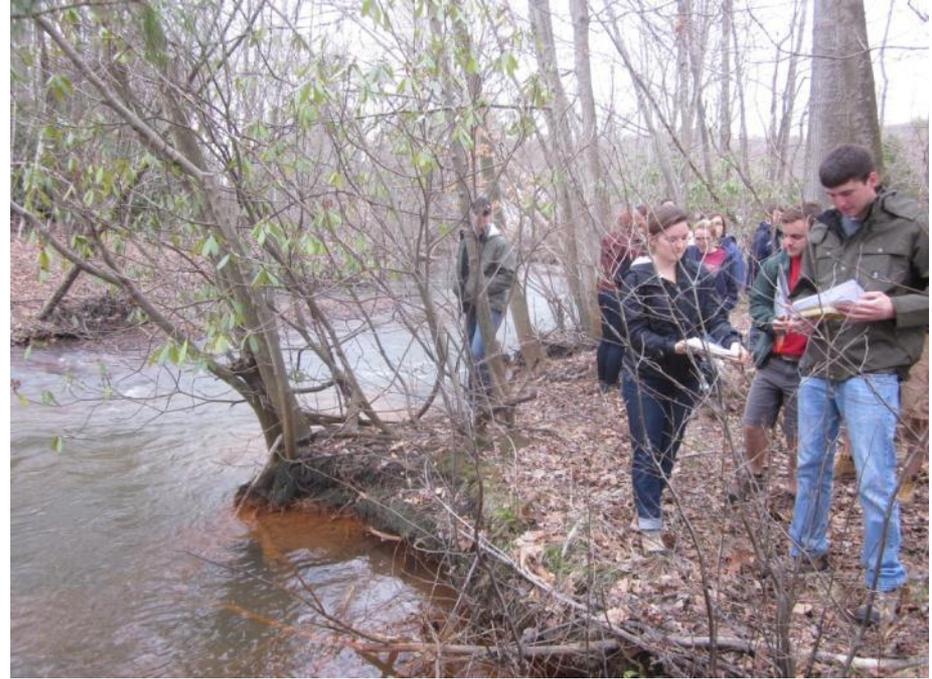
Stop #2 – The Oak Hills Boreholes. These boreholes discharge water directly into the West Branch of the Schuylkill River, degrading the water quality. As this stop is just downstream of the Pine Knot Discharge as well, the quality of the water of the West Branch at this location is highly dependent upon the mine discharges.

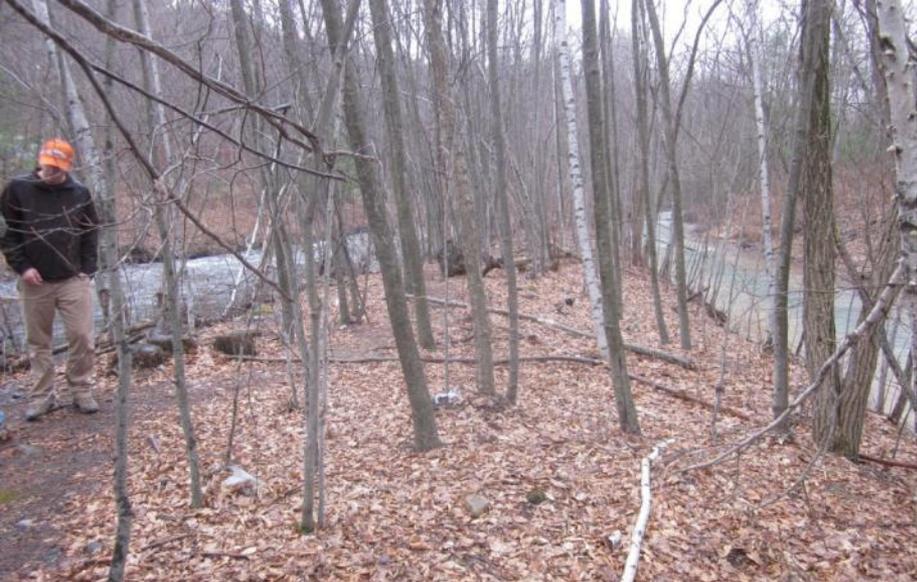
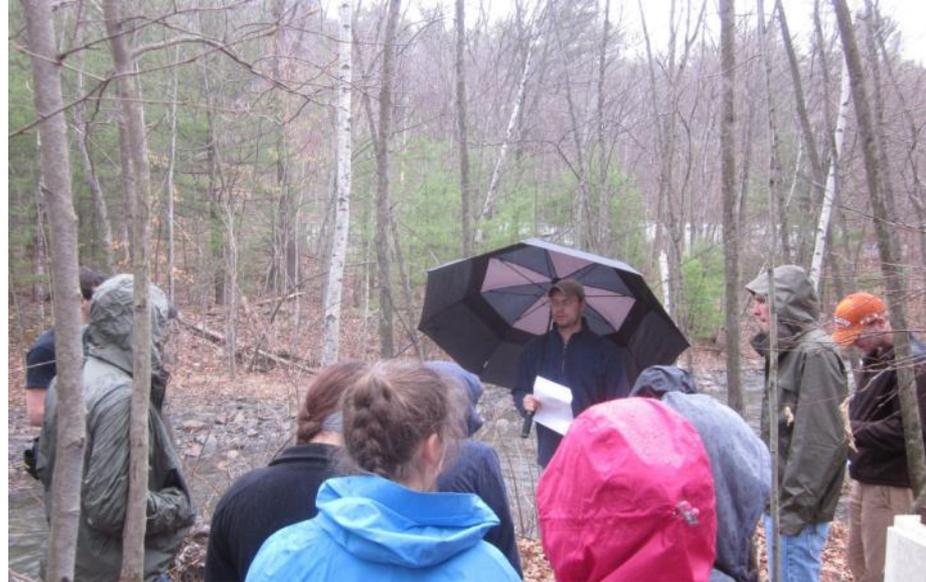
Stop #3 – The confluence of the West Branch (left) and the Pine Knot Discharge (right). There is sometimes enough Aluminum in this discharge to coat the stream channel with white precipitate.

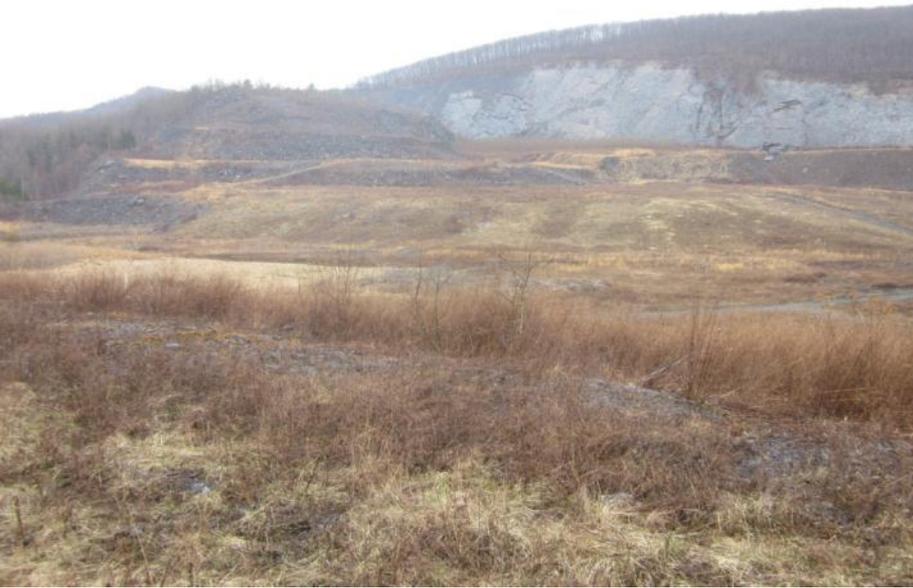
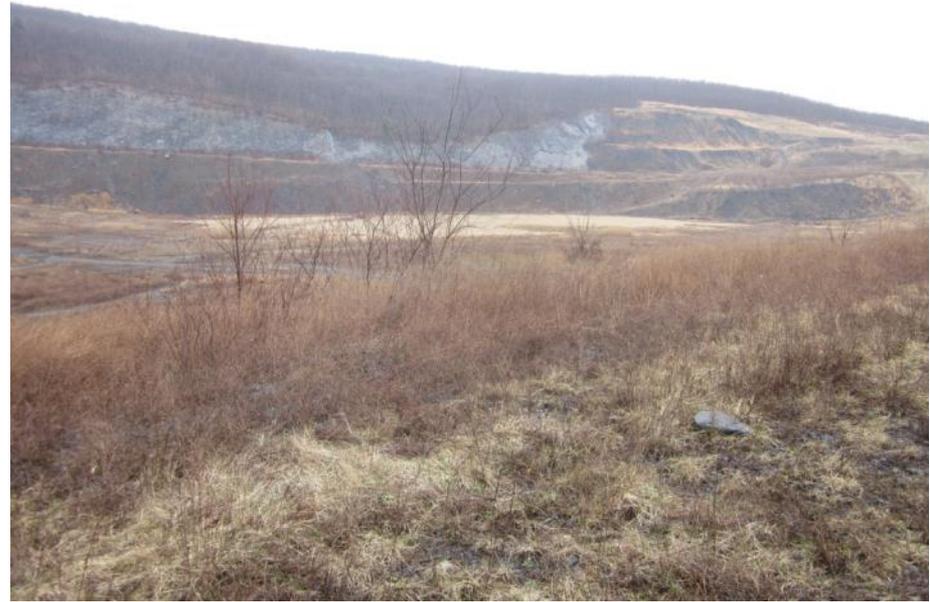
Stop #4 – Greenbury Reclaimed Strip Mine. This location has been reclaimed to its 1972 grade. Biosolids have been used at the poplar test pit. After seven years of growth, the poplars treated with biosolids are more than 10 ft tall while the untreated poplars are less than 4ft tall. This renewable resource can be used for paper pulp.

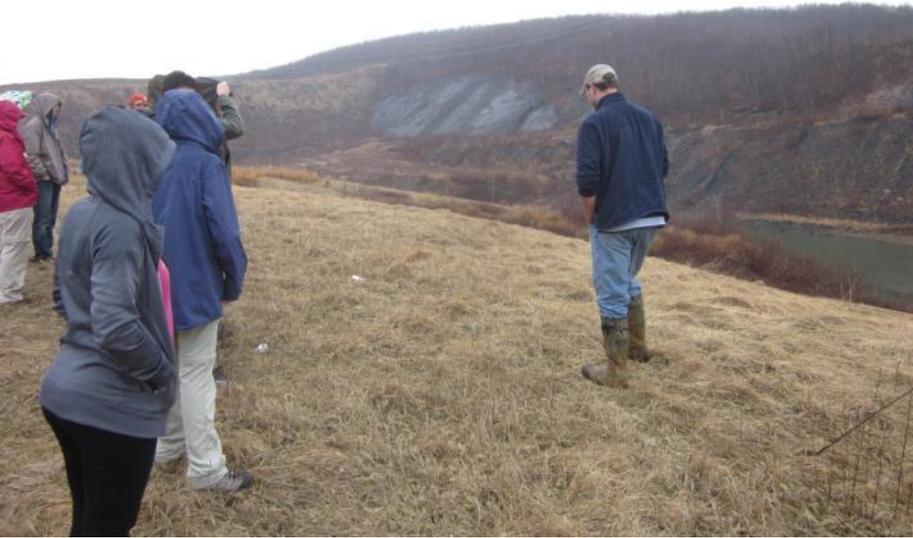
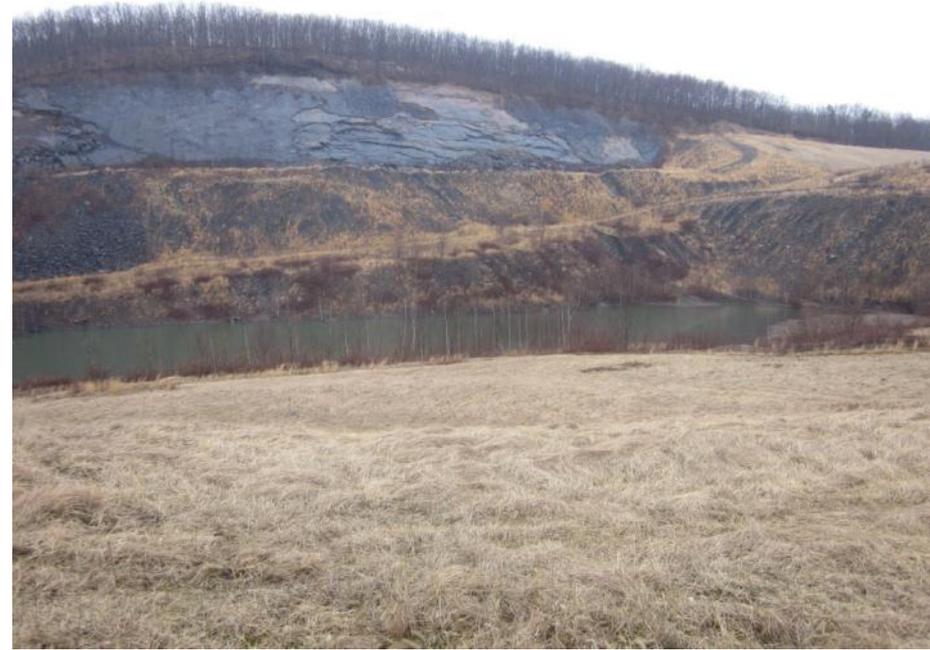
Stop #5 – The Greenbury Reclaimed Strip Mine. The water at the base of this reclaimed section of the strip mine is blocked from entering the natural stream channels of the watershed. It will instead seep unto the underground mine workings over time. It provides wetland habitat for ducks.

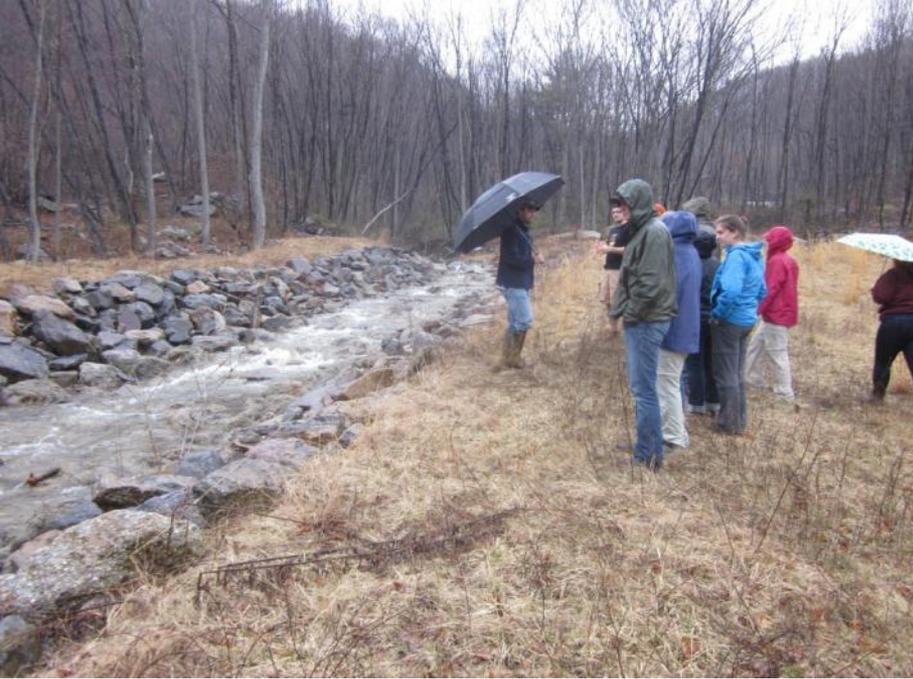
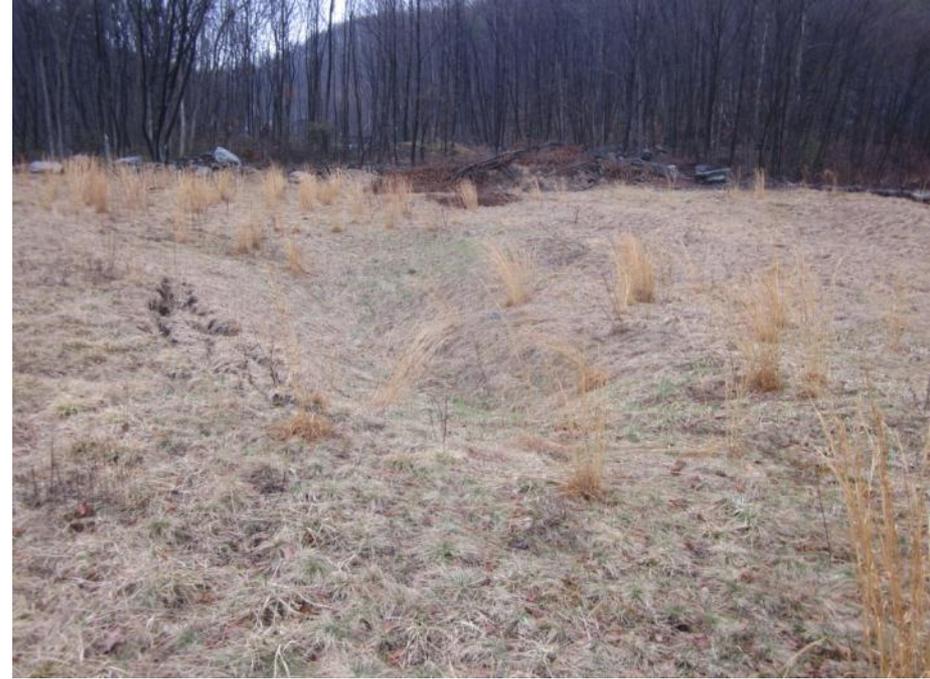
Stop #7 – Wheeler Run. This stream channel used to have a flume which kept the water from entering the subsurface mine pool. However, the flume was in a state of disrepair. The Schuylkill Headwaters Association removed the flume and lined the stream channel with an impermeable barrier. Due to the high flows that are experienced in this area, they also had to coat the rocks in the stream channel with cement to hold them in place. Over time the cement will weather away and be replaced with natural sediments. Since the stream channel work, a crop fall has started to develop beside the stream.

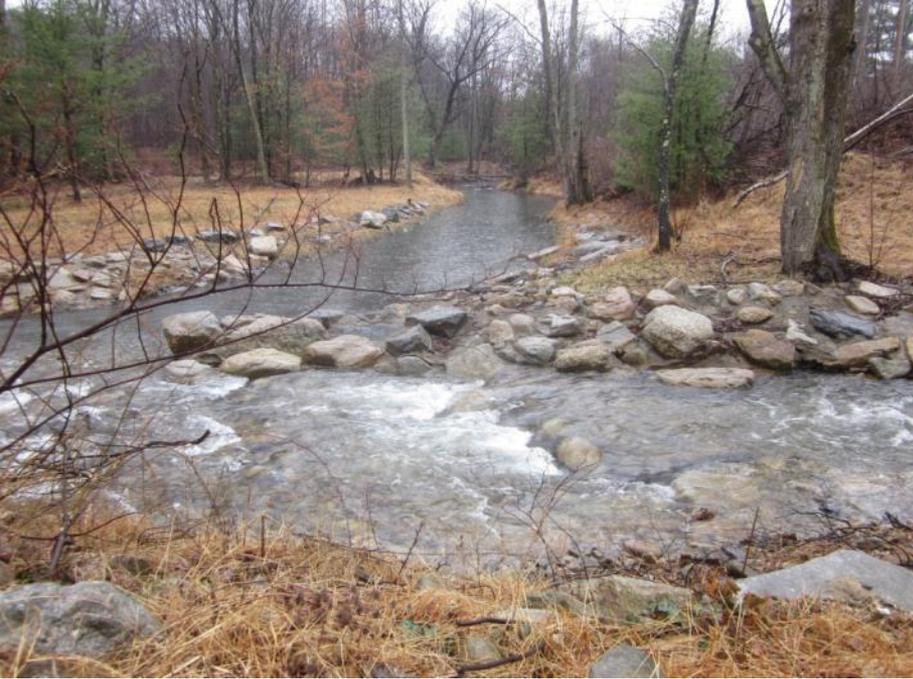
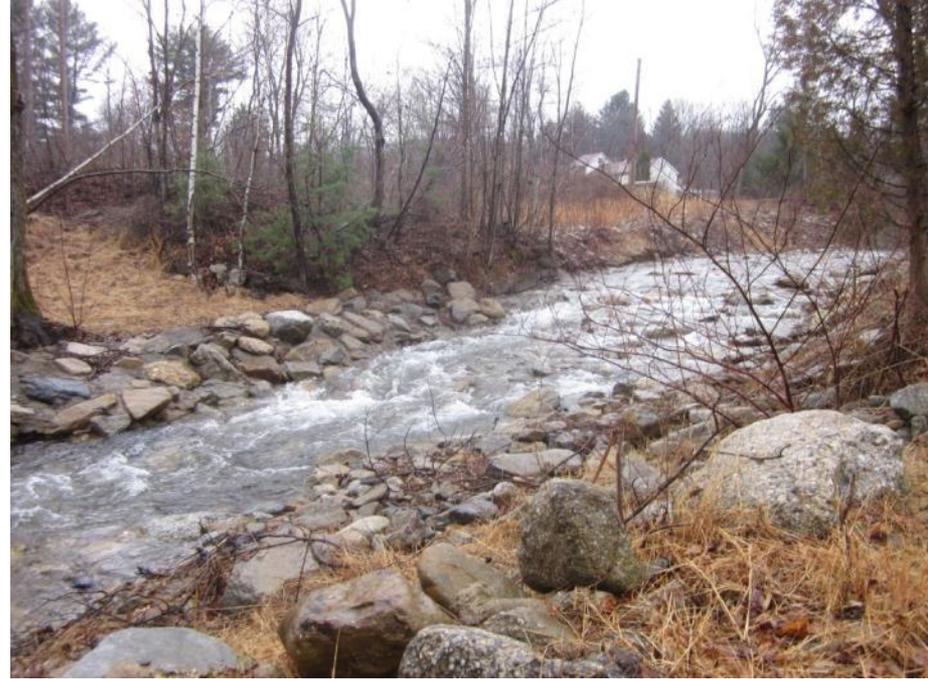
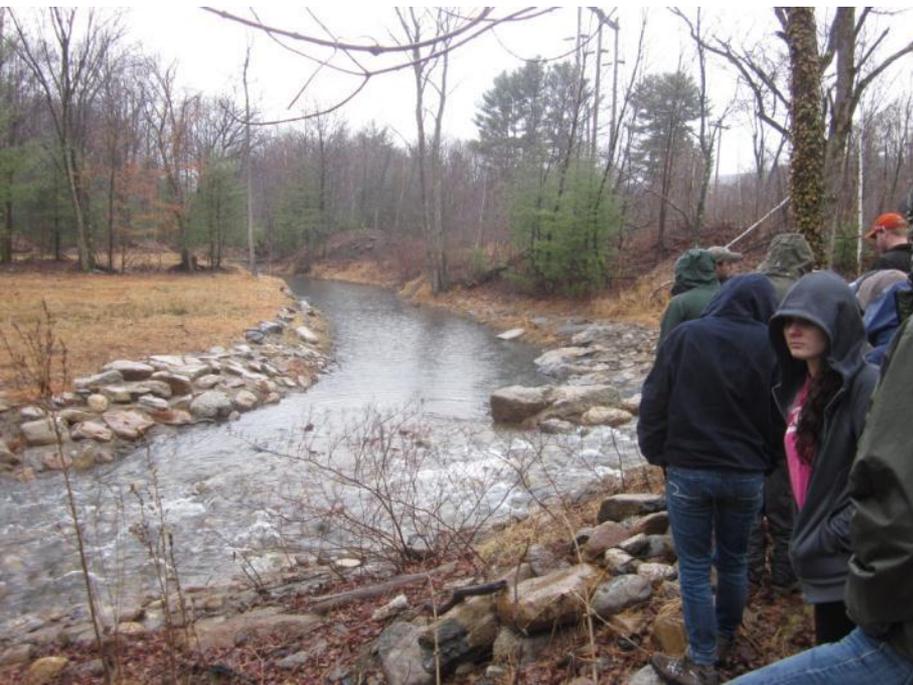
Stop #8 – Dyer Run. This is another example of a stream channel which was lined with an impermeable barrier and covered in large rocks. Cement is only used in some places along the length of the channel. Location of seeps in the stream channel were found with resistivity surveys.

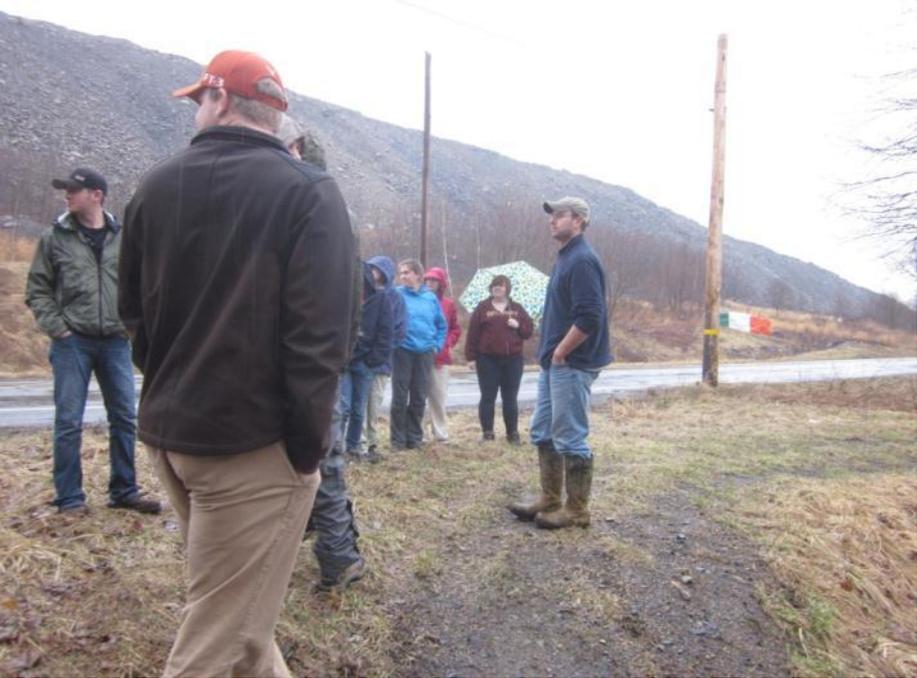
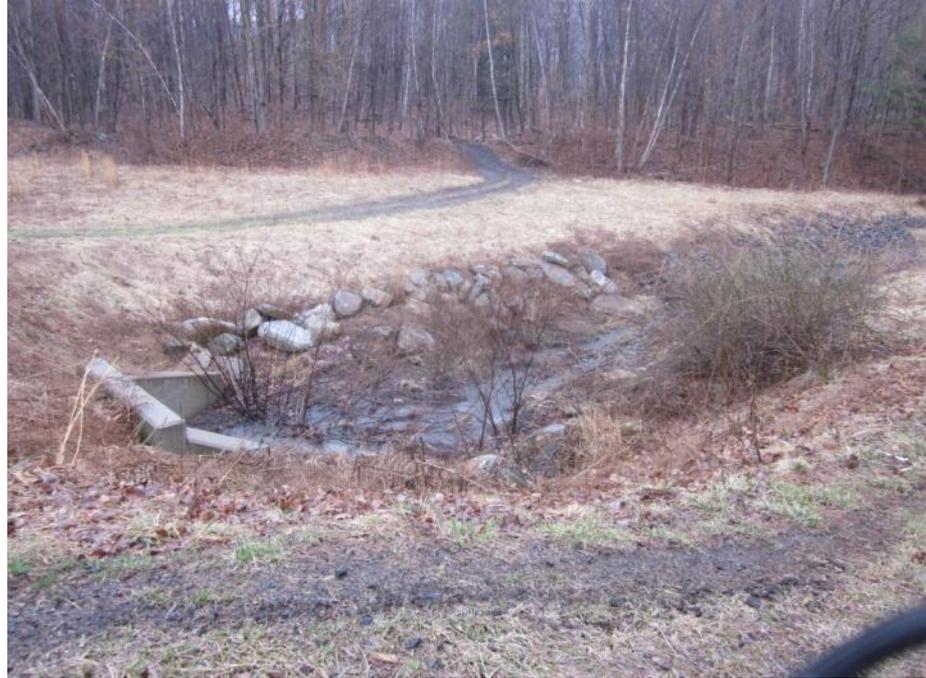
Stop #9 – Diverting the water. Water which used to be diverted into a crop fall, with a connection to the subsurface mine pool, is now diverted to the stream channel to decrease the total volume of water that exits the mines as AMD.

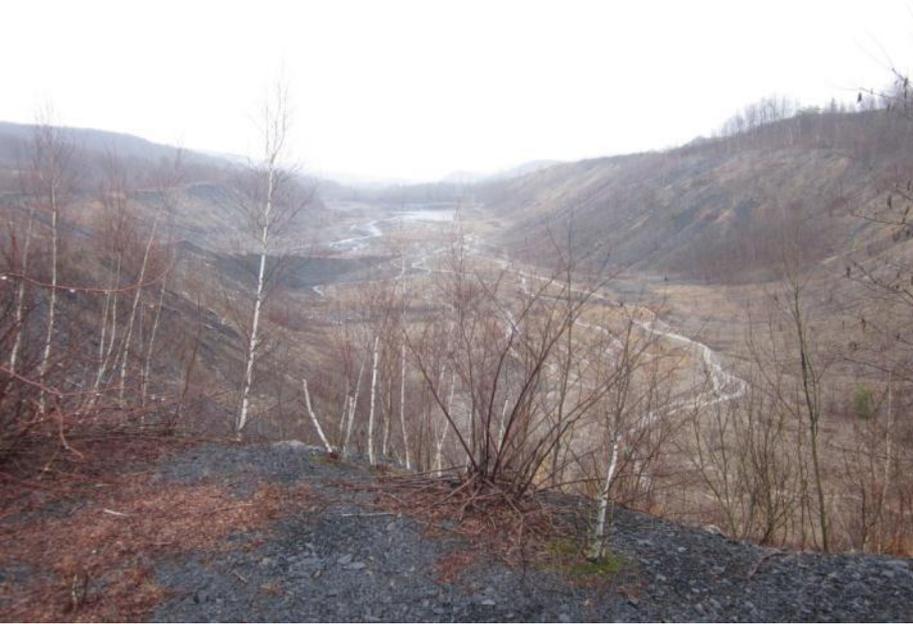
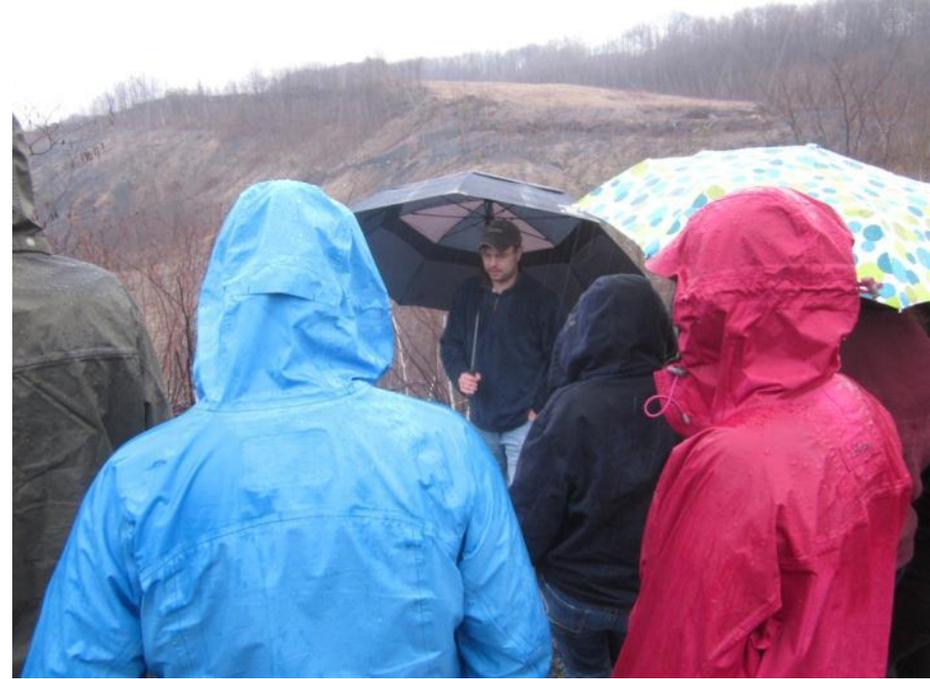
Stop #10 – The top of the watershed. The final stop of the day was at the headwaters, an area which has been extensively mined as apparent from the piles of overburden on either side of this valley.
