Locust Lake Dam Discharge and Holding Ponds

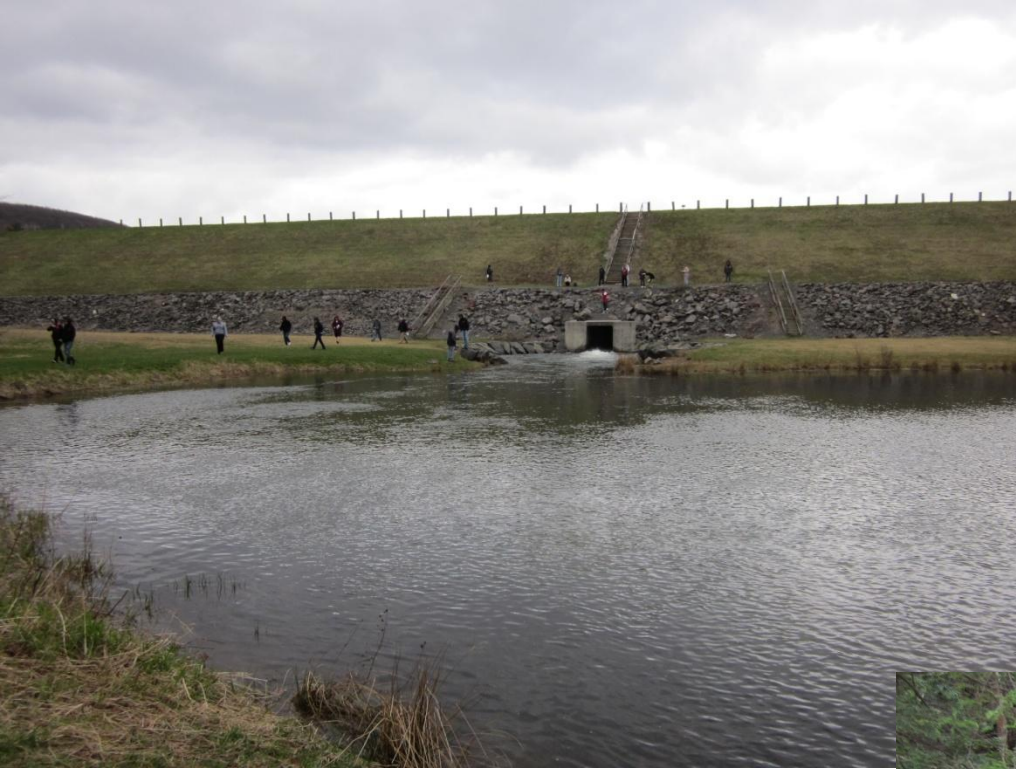
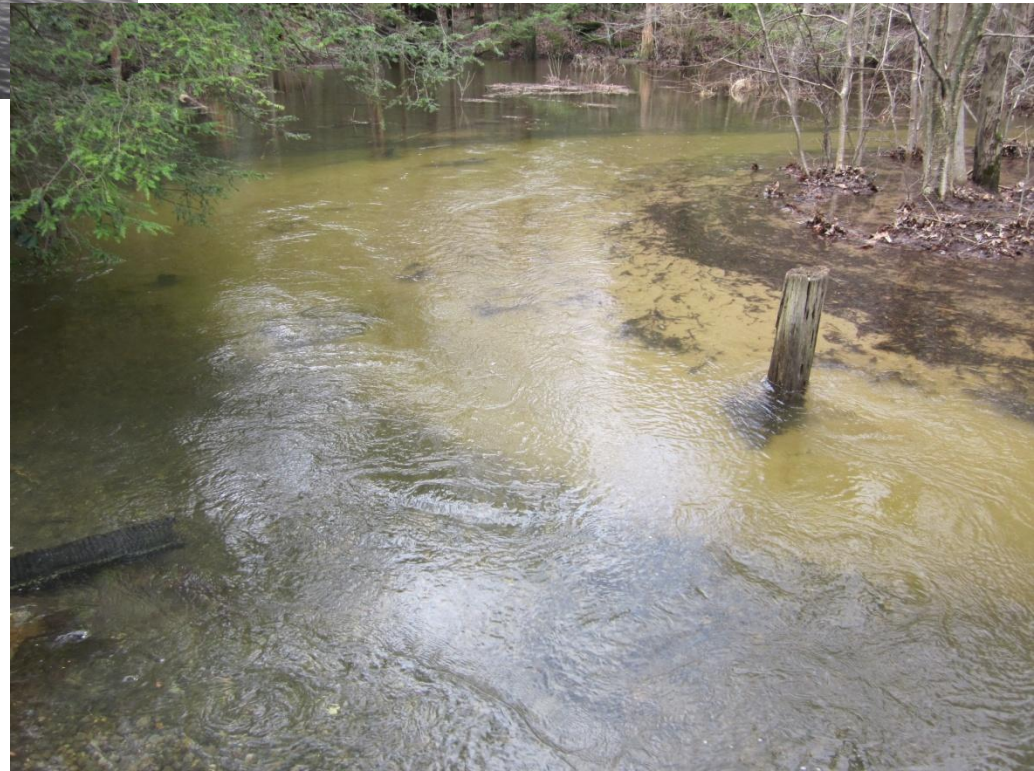
Locust Creek feeds Locust Lake and exhibits cut bank and point bar features. Notice the size of sediment deposited on the point bar compared to the cut bank.

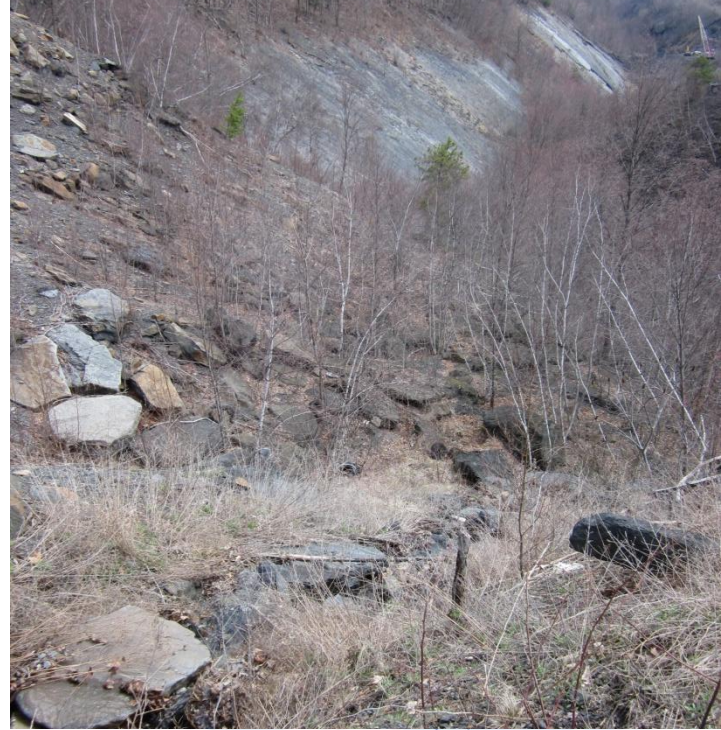
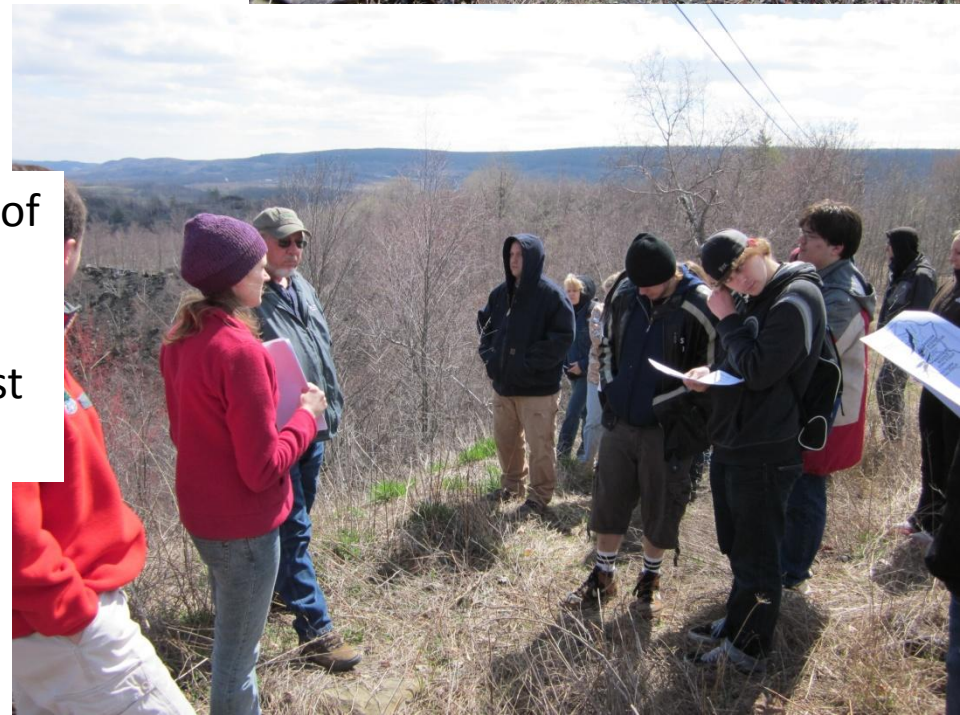
Catawissa Street Overlook – the Anthracite Coal of PA is a very important resource. Notice the lines in the distance (bottom right) showing remnants of mining in the southernmost extent of the anthracite beds.

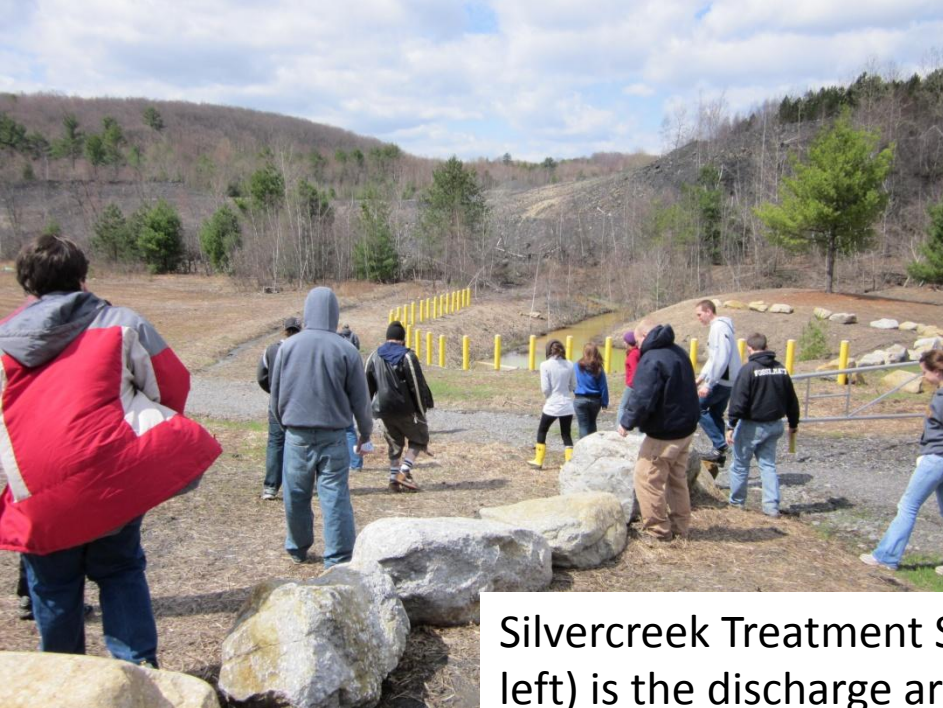
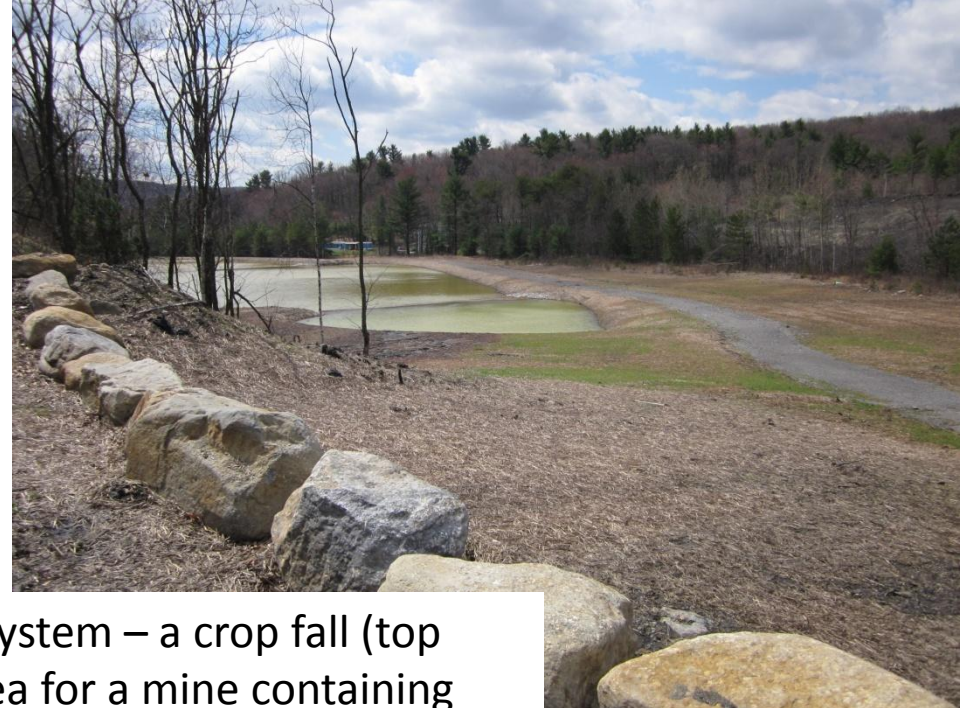
Silvercreek Treatment System – a crop fall (top left) is the discharge area for a mine containing iron rich water (notice blue coloration of dissolved iron). The treatment system was developed and constructed at a cost of \$800,000.

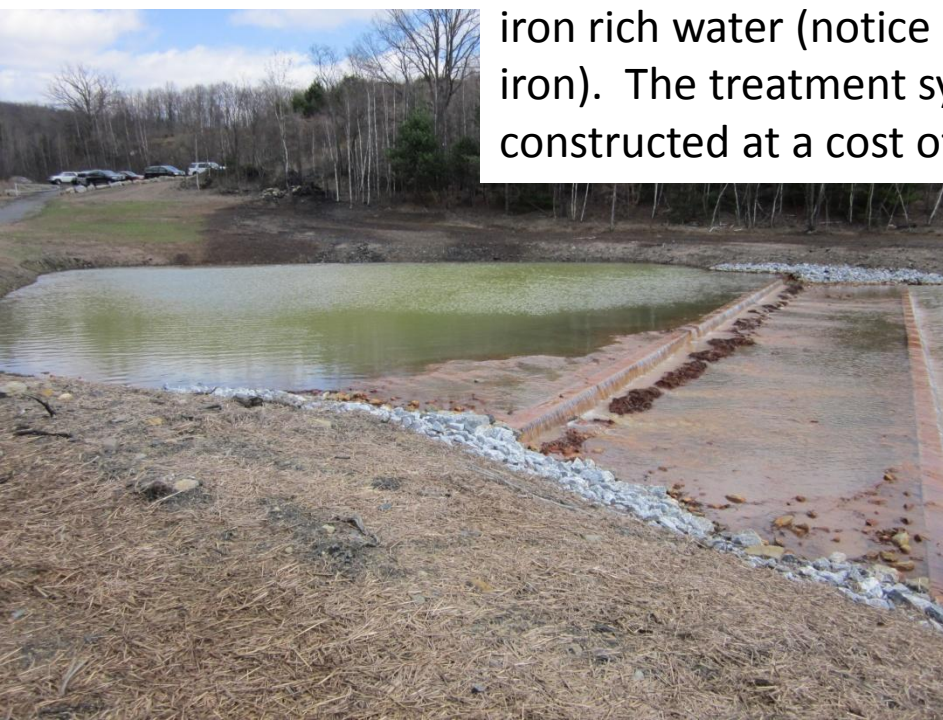
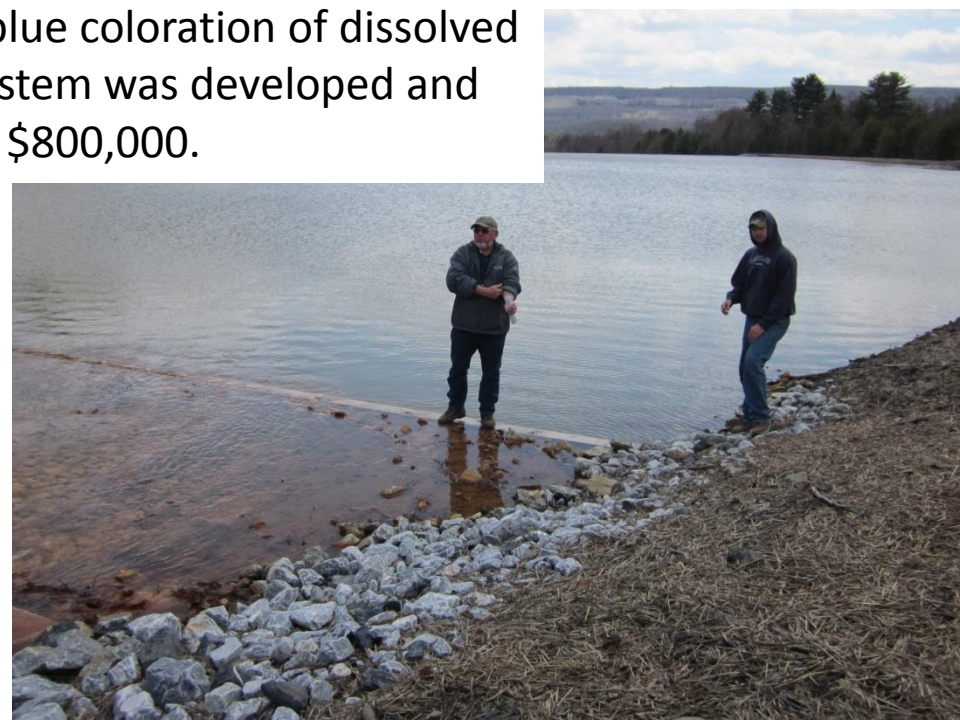
Silvercreek Treatment System – water from the crop fall is diverted to a series of retention pods which allow iron to settle and pass the water over beds of limestone to increase pH.

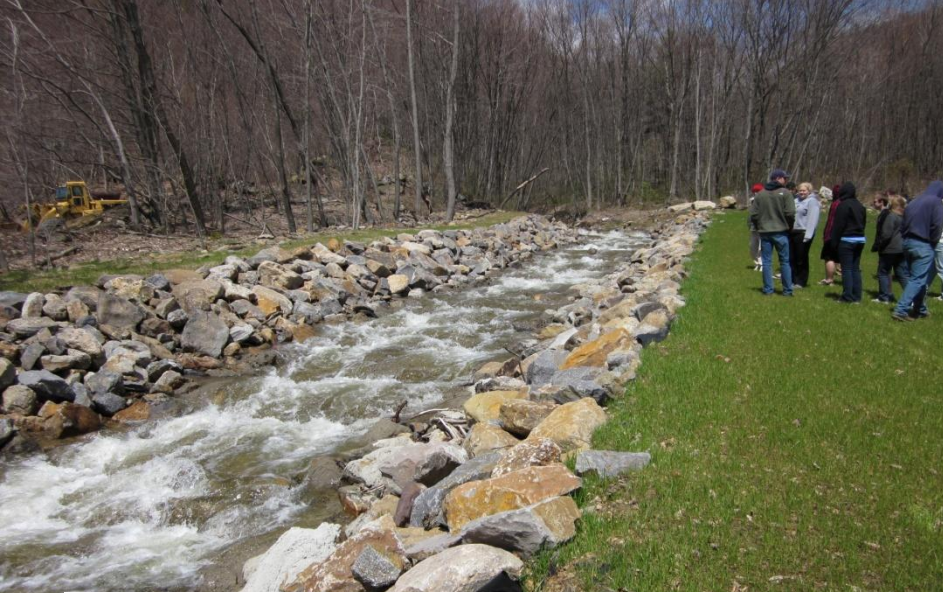
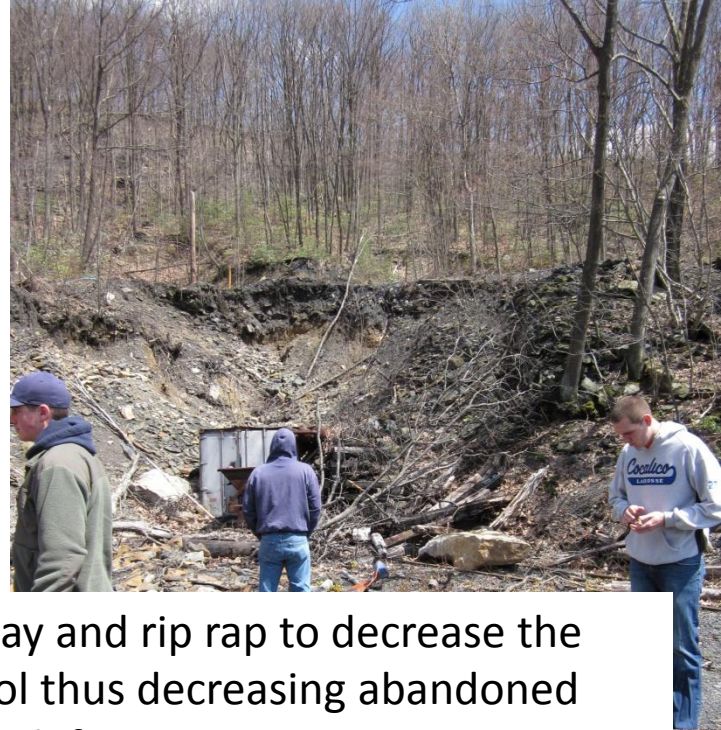
Wheeler Run - This stream channel has been lined with clay and rip rap to decrease the recharge that was occurring to the underground mine pool thus decreasing abandoned mine discharge. The old flume may be seen at the bottom left.

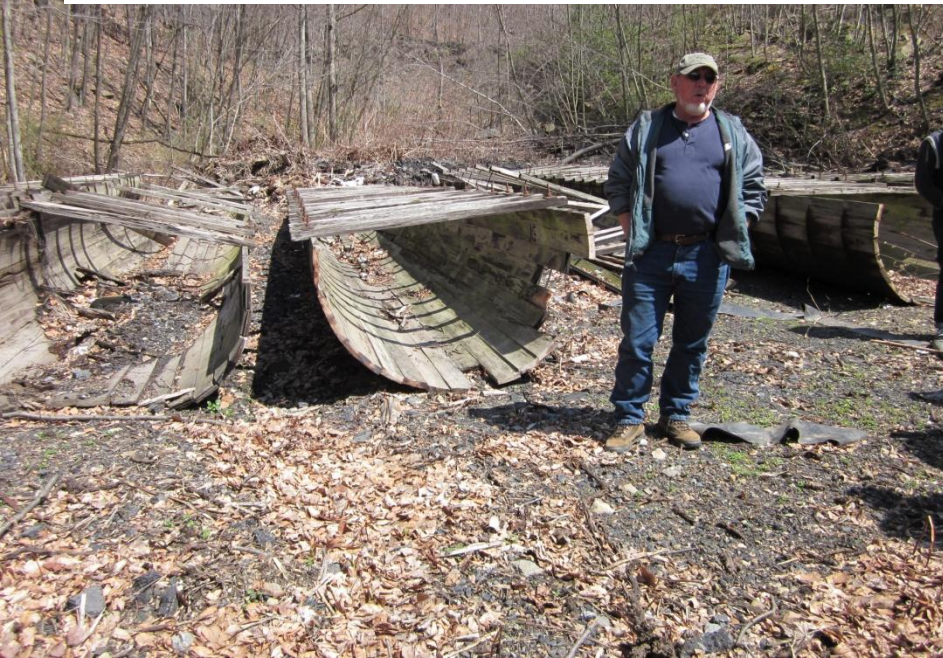
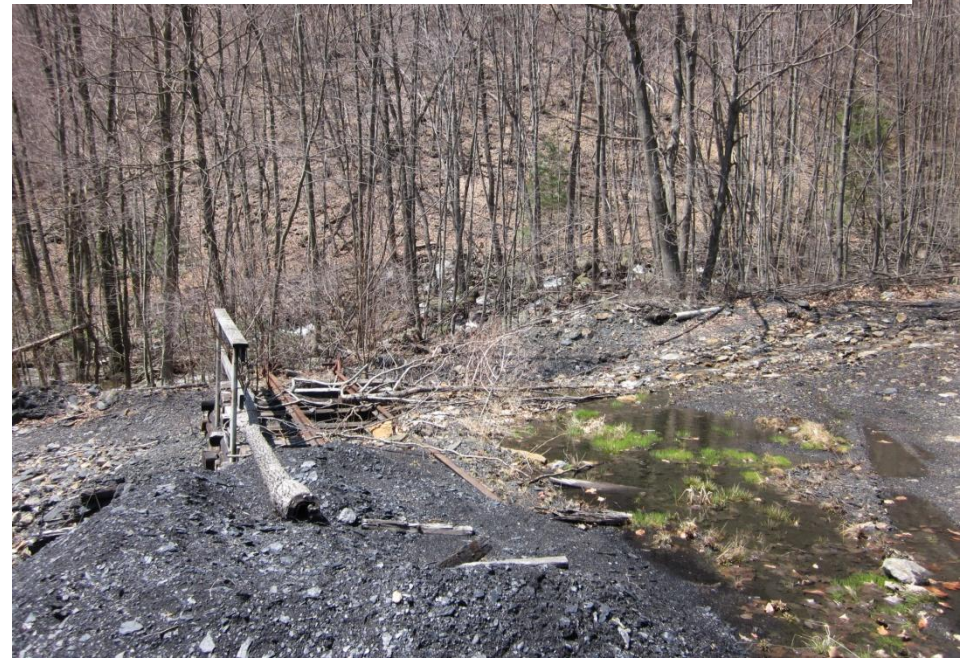
Wheeler Run – The old mine shaft is visible at the surface.

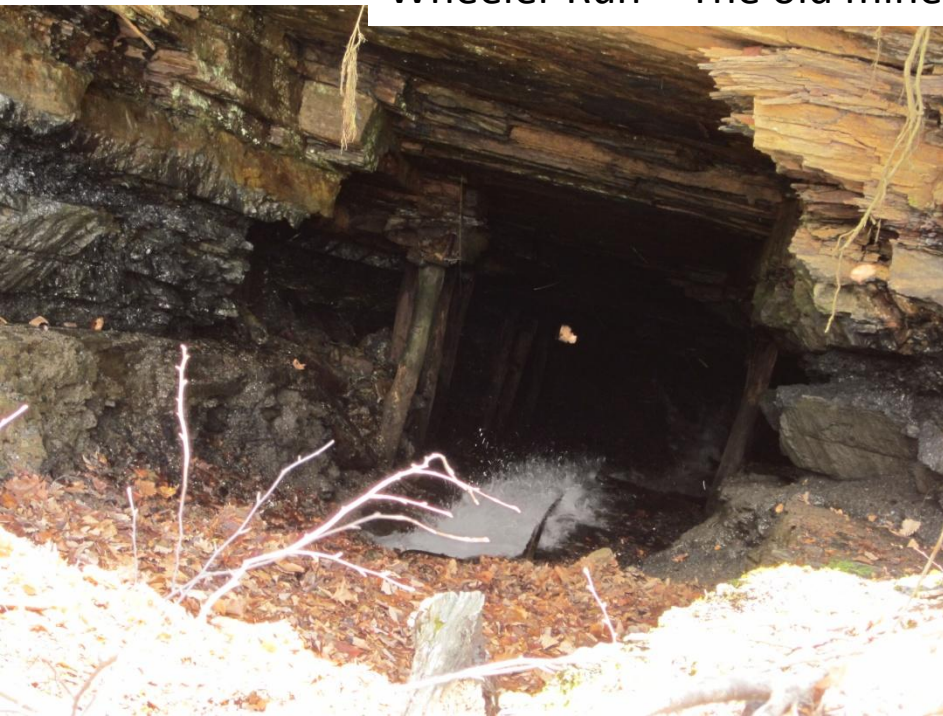
Wheeler Run – A small stripping pit allows water to infiltrate into the mine pool (top).

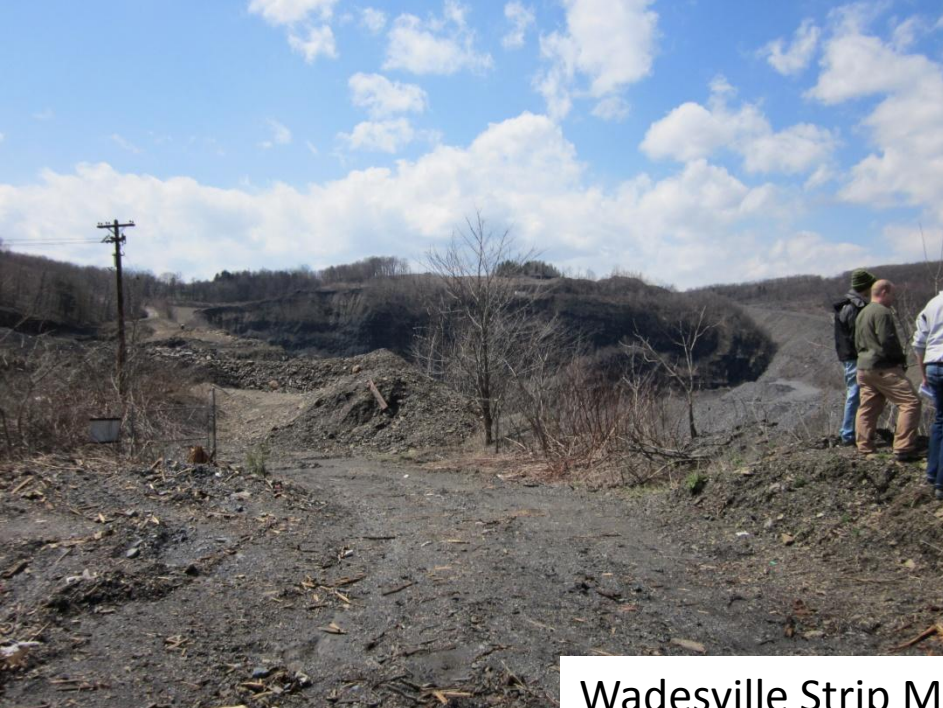
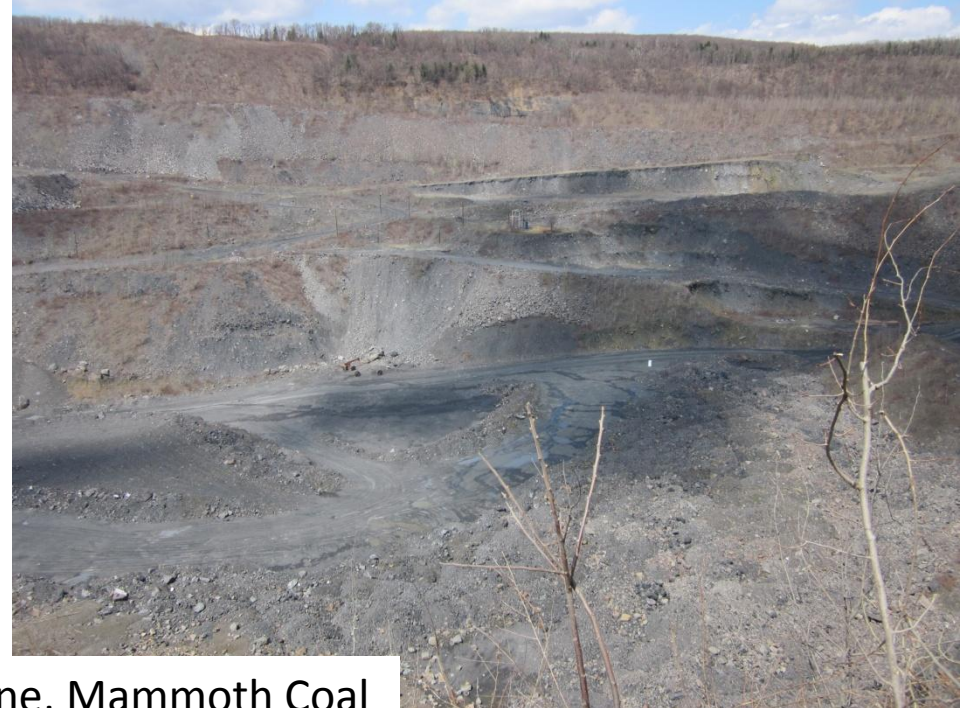
Wadesville Strip Mine, Mammoth Coal Vein – Notice folded rocks in far walls
