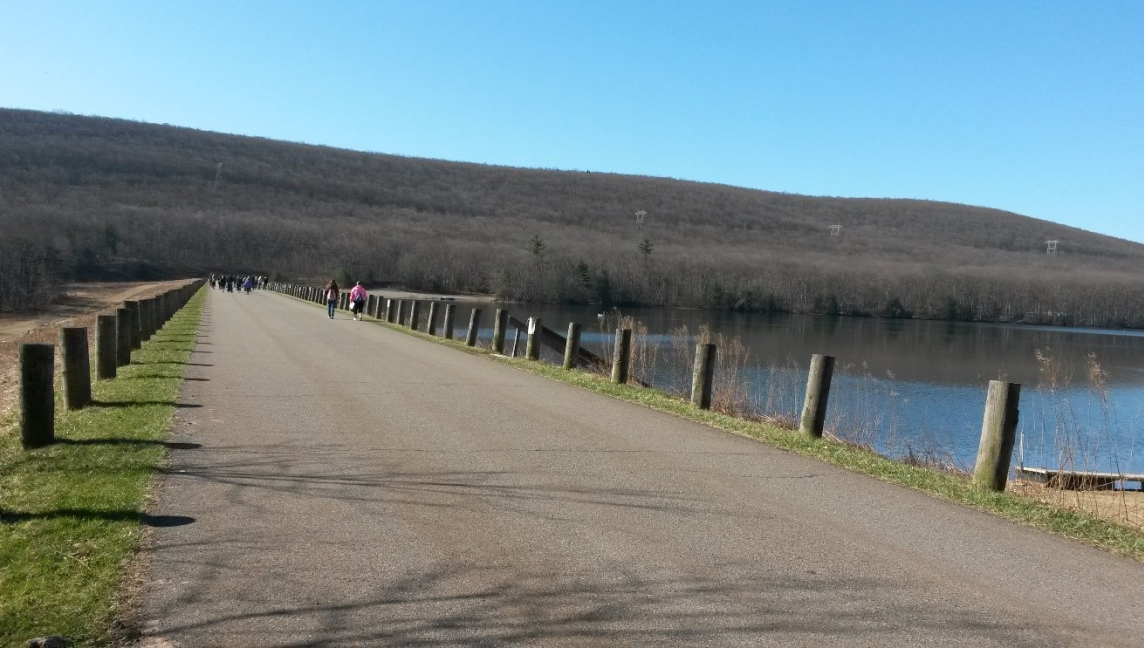
Locust Lake State Park is in a clean watershed due to topography. The dam was constructed to create a reservoir for recreation.

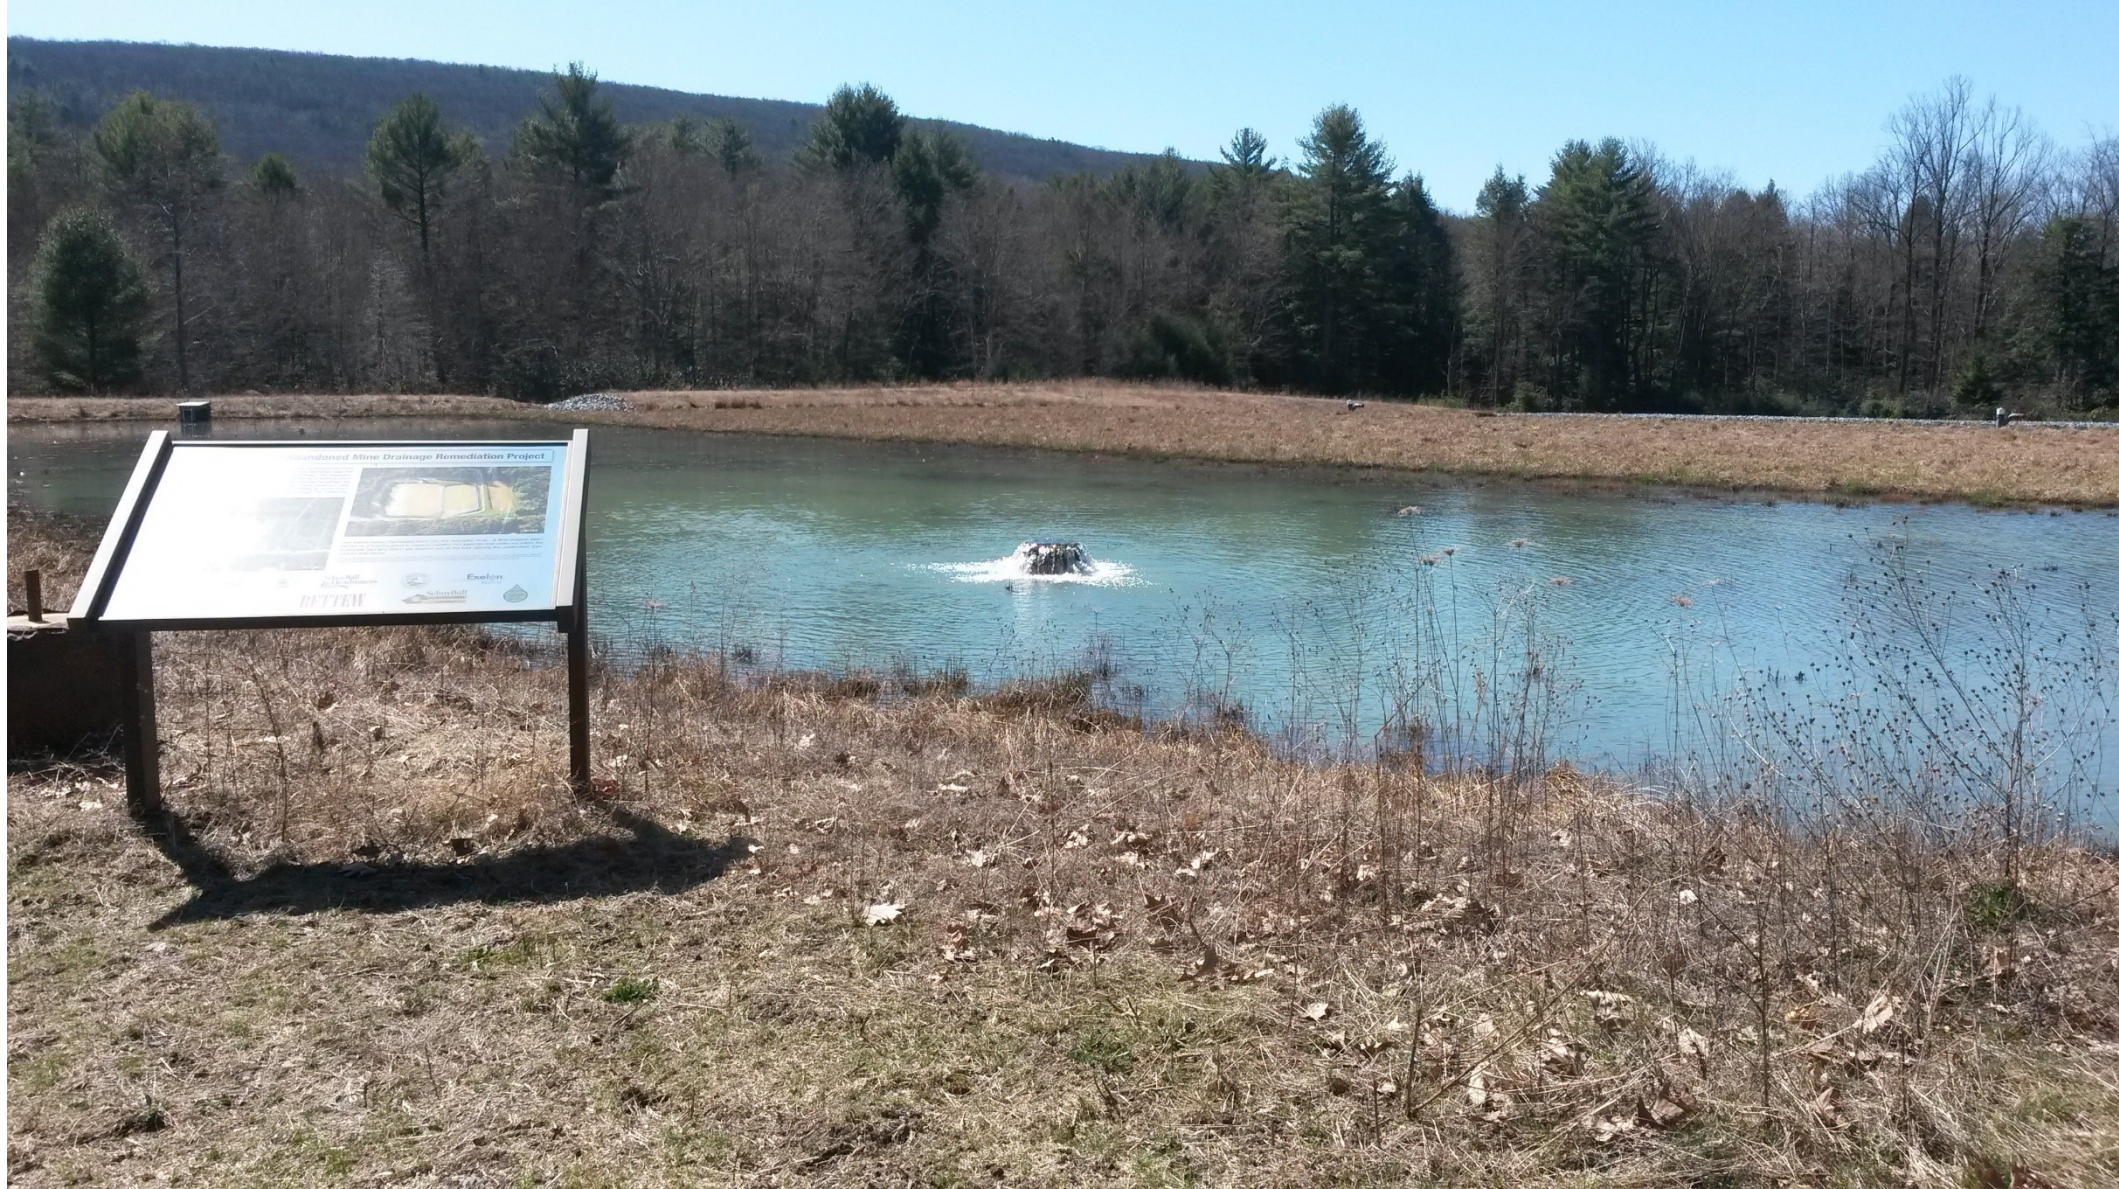
The Schuylkill Conservation District and the Schuylkill Headwaters Association work toward a cleaner watershed through passive remediation projects such as this wetlands at Mary-D. Abandoned Mine Drainage (AMD) enters the system with low pH and high iron levels. The water is passed over limestone to increase the pH. There are a series of pools in which the iron can oxidize and precipitate out of the AMD

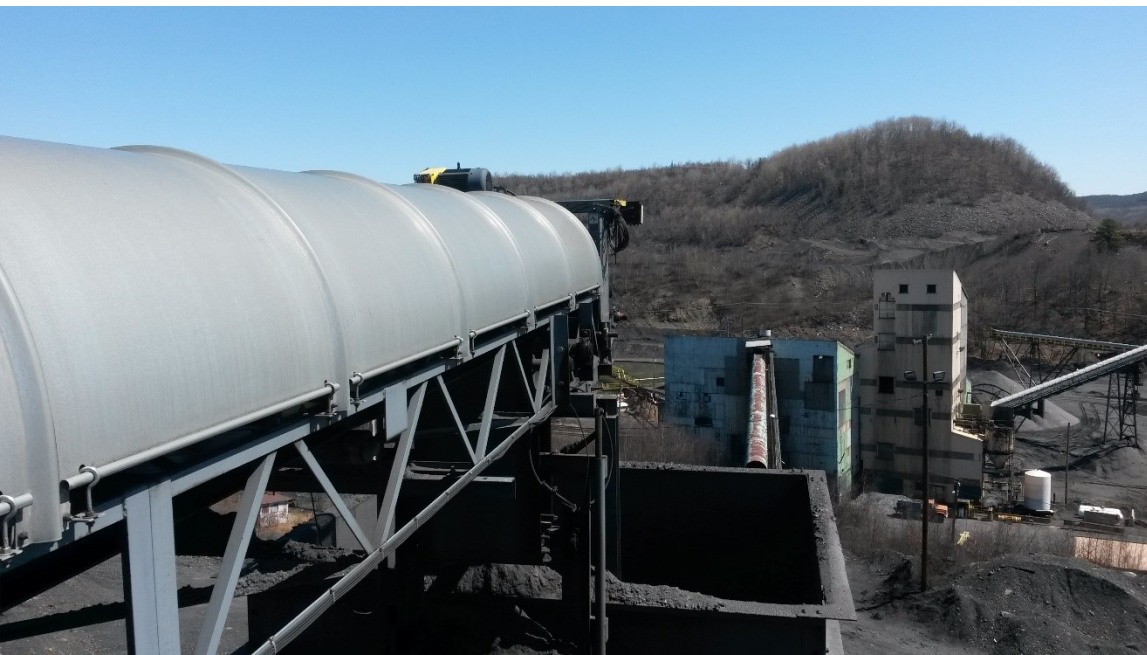
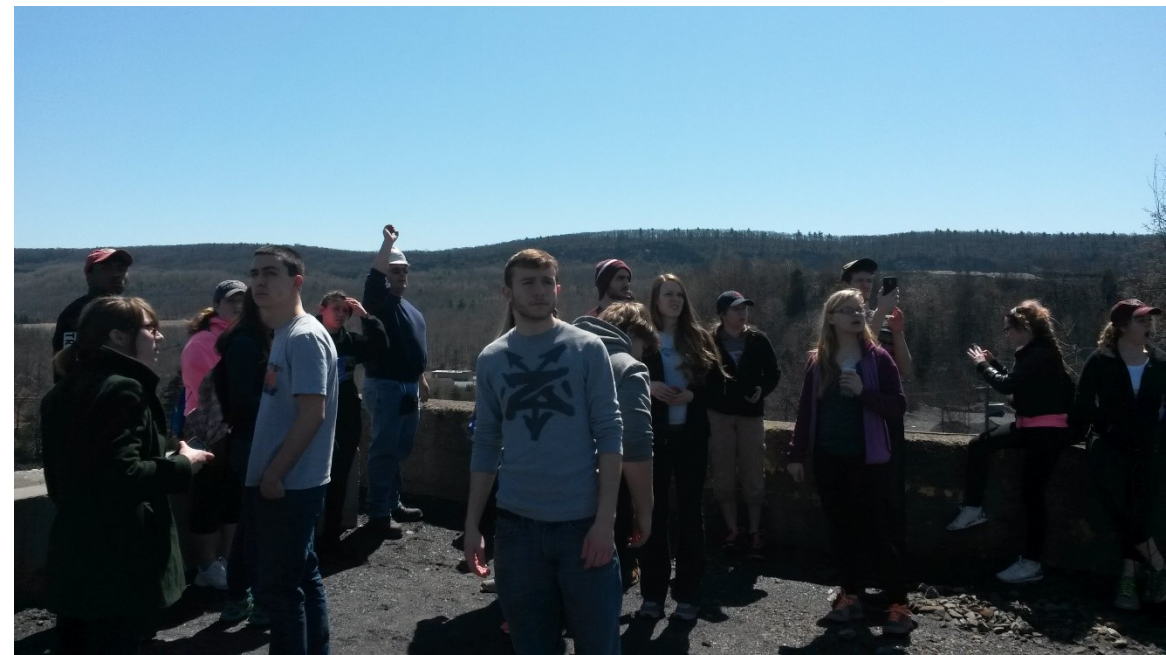
John Hadesty of Lehigh Anthracite gave us a tour of the crushing and sorting facility. Anthracite from this mine is used for filtration, welding, stainless steel creation, the carbon in tennis rackets, and many other products

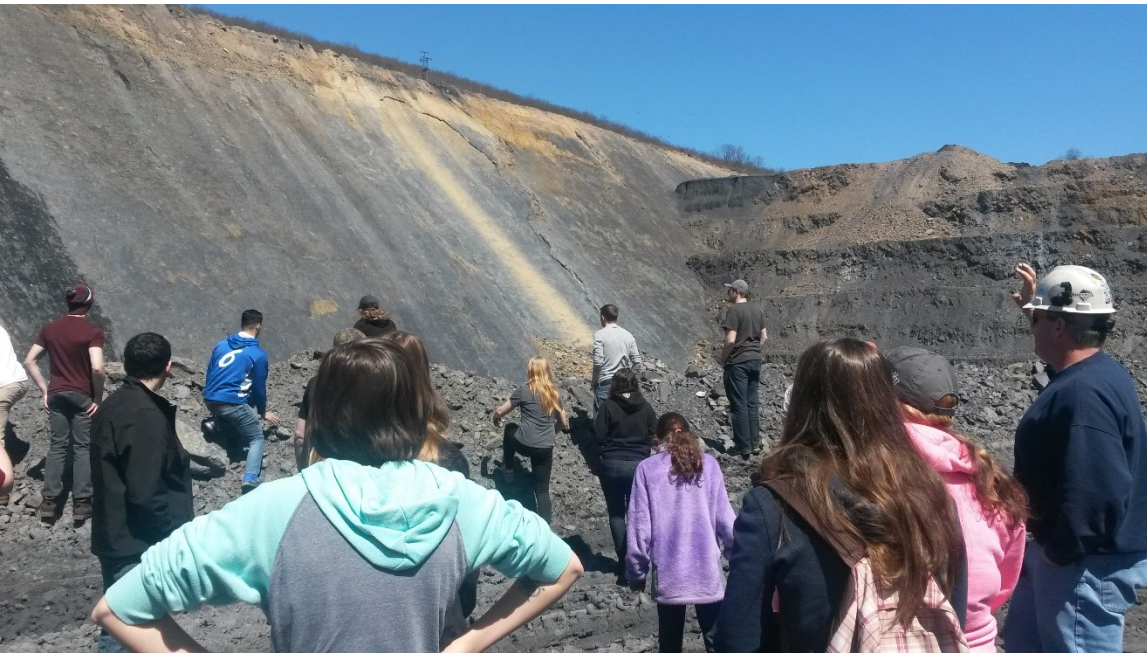
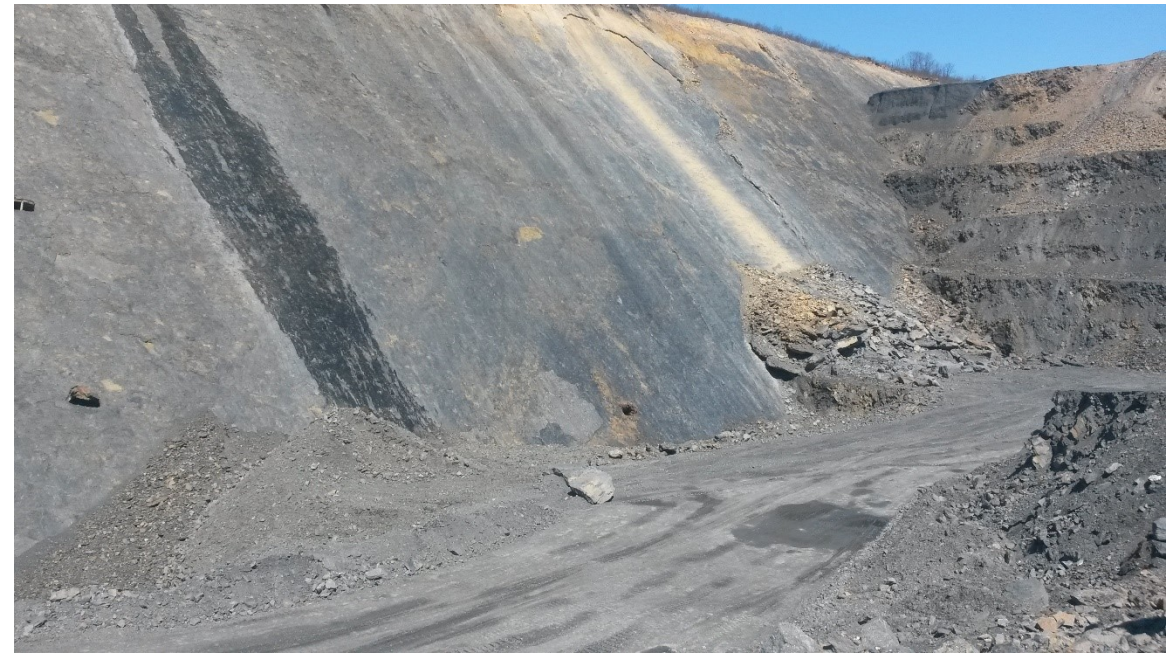
From the base of the excavation pit, the terraces were visible as were the holes in the bottom rock from deep mining.

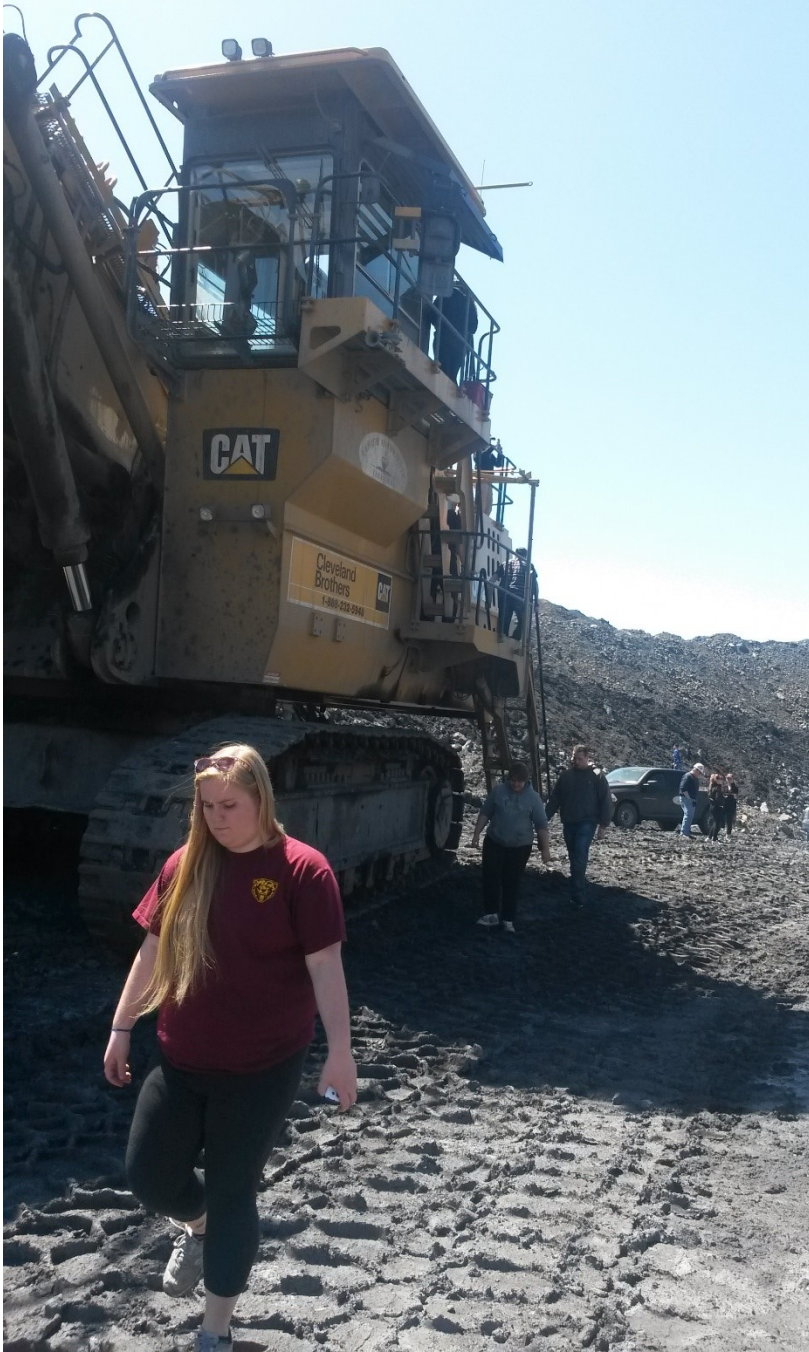
The hydraulic shovel used for excavating cost over 4 million dollars.

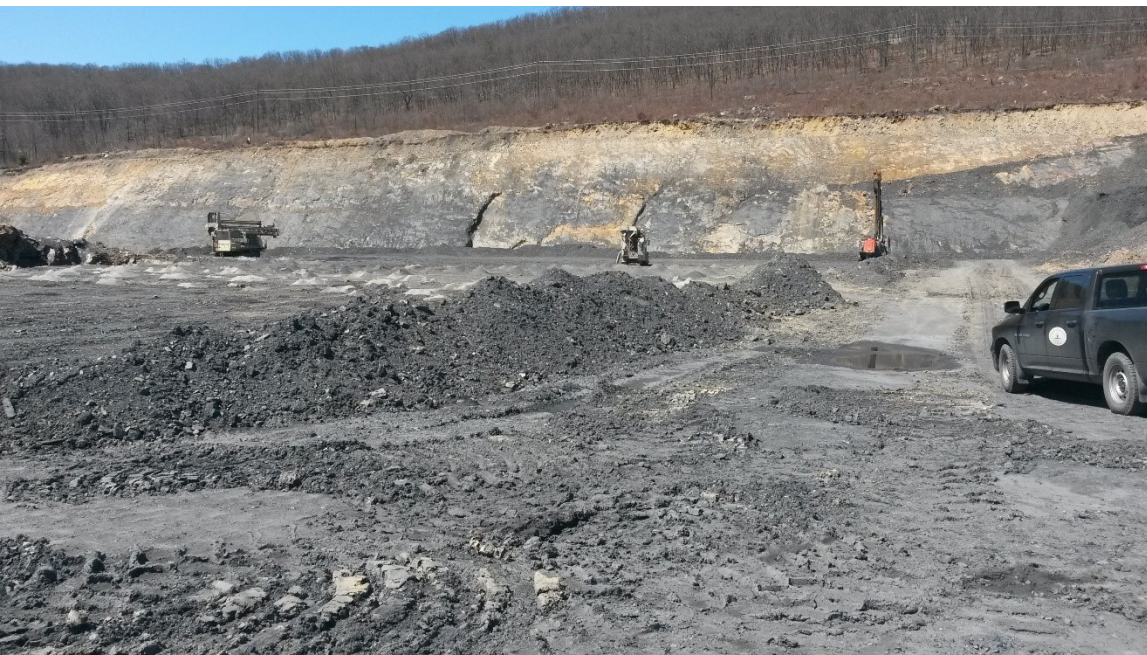
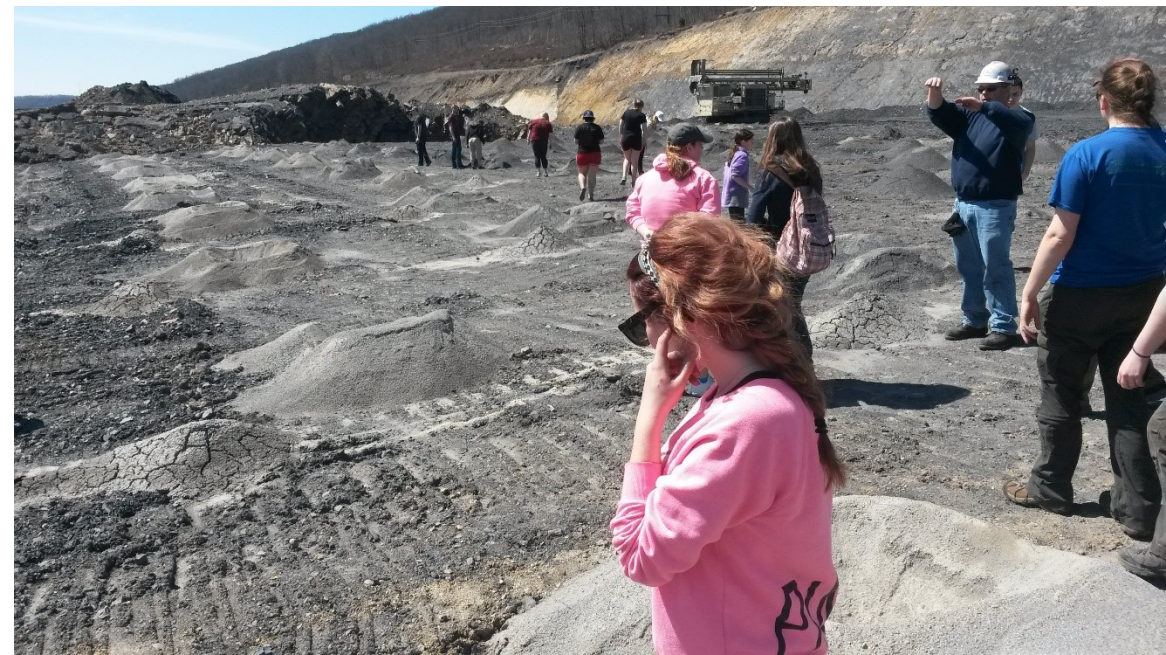
John showed us the pit where excavation had occurred earlier this year and explained the process of blasting.

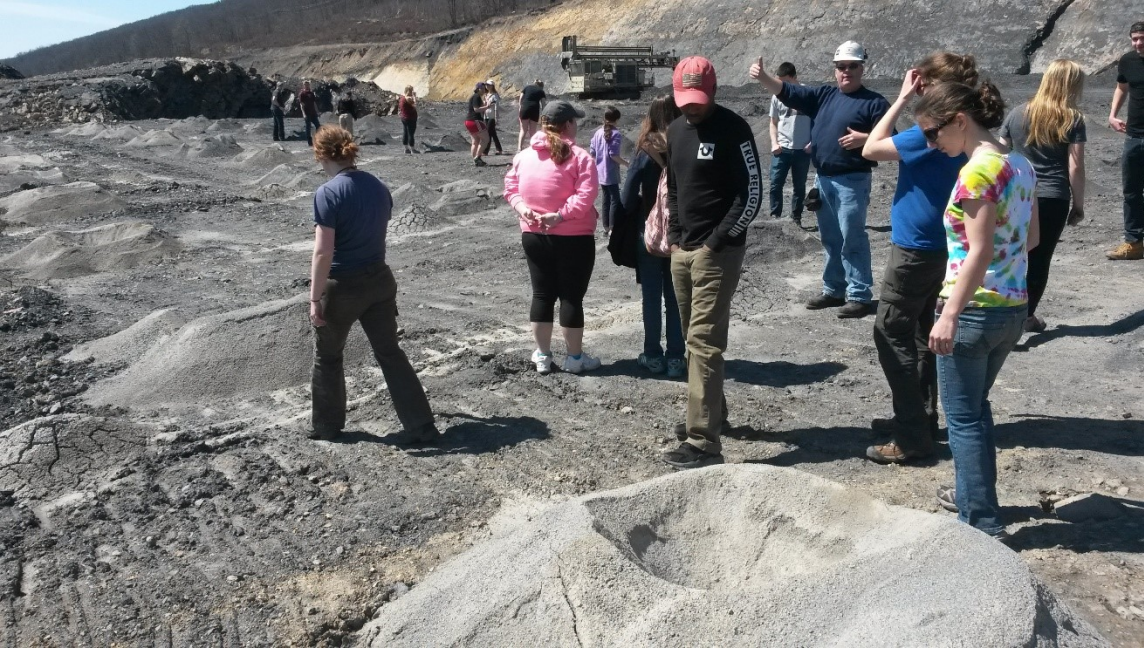
The boreholes at this site were drilled in a pattern to fracture the rocks and make excavation possible. A fertilizer-based explosive will be used

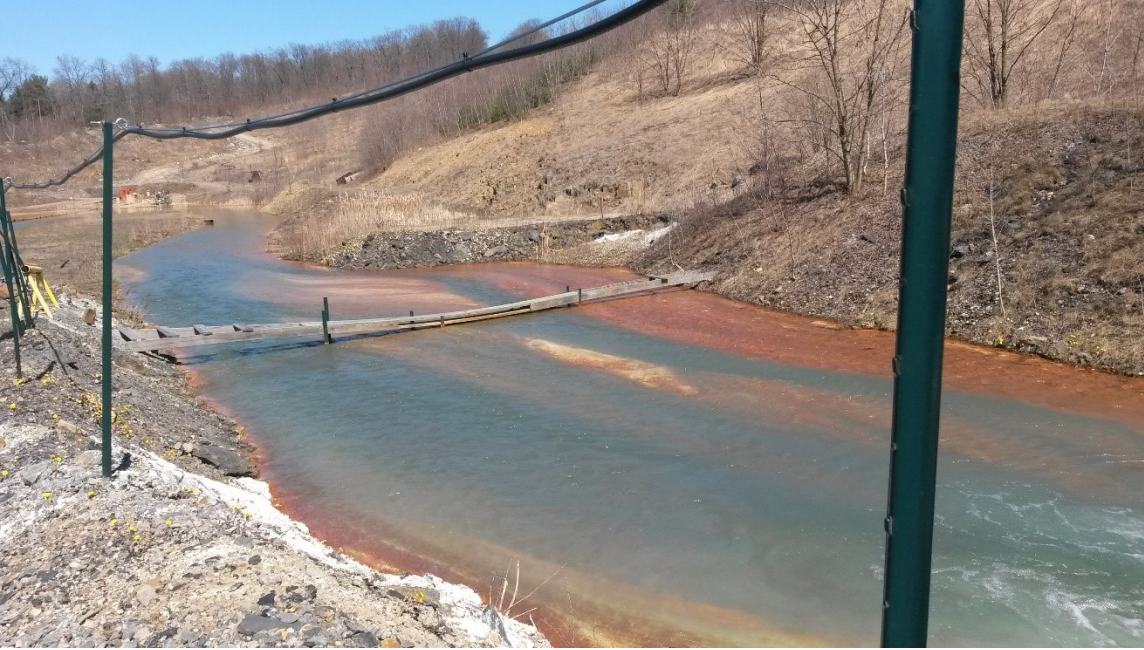
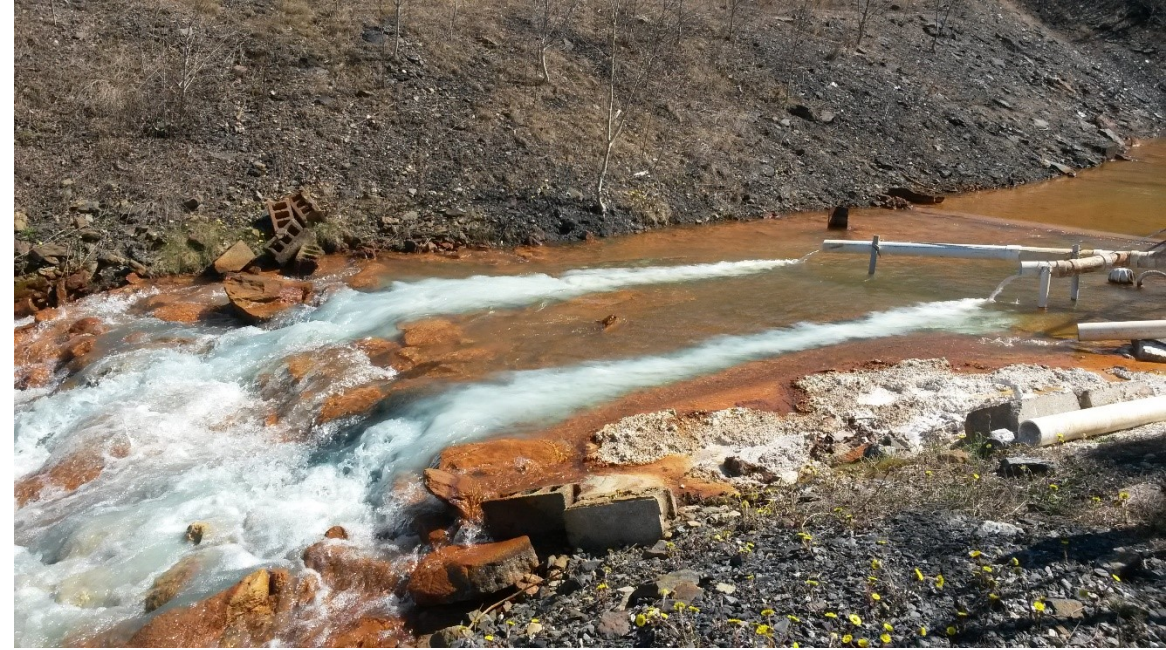
The 309 Discharge is a site of active remediation where the water is being treated to increase the pH and remove iron prior to discharge into the Little Schuylkill River. Following the active treatment, the water flows through a wetland area where iron precipitates prior to entering the Little Schuylkill River.
