Locust Lake State Park is in a clean watershed due to topography.  
The dam was constructed to create a reservoir for recreation.  
The drain in the lake automatically controls the lake level.

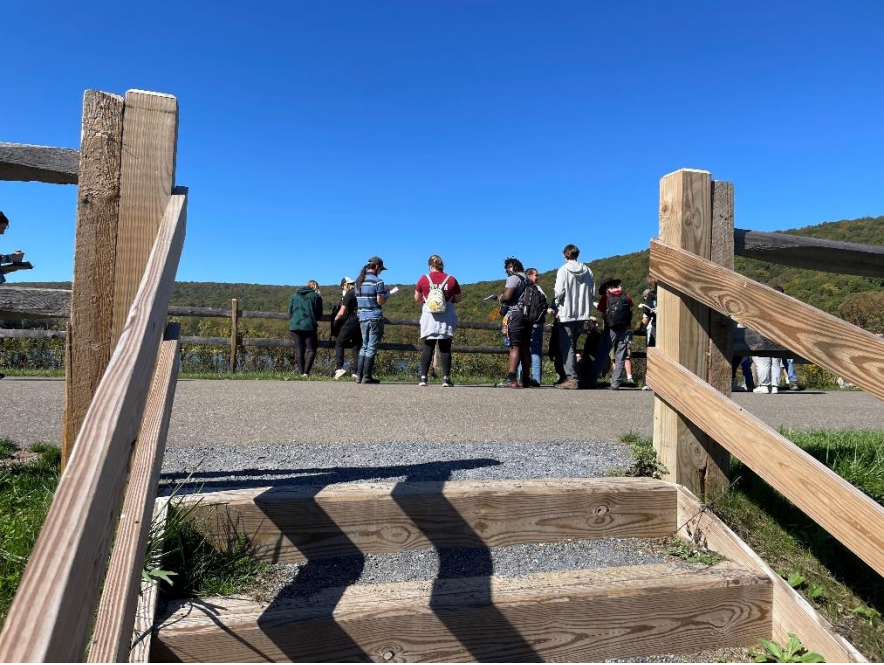
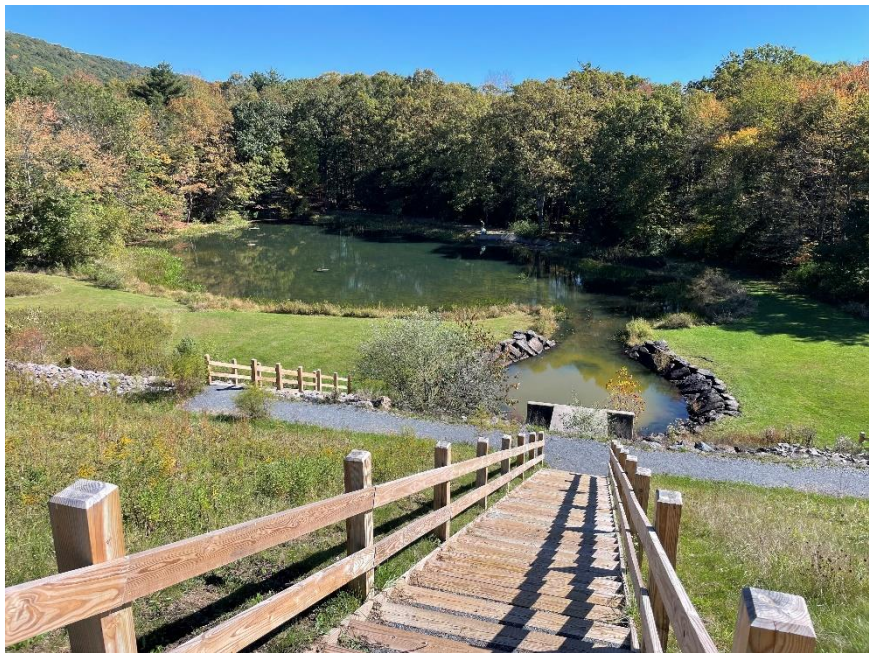
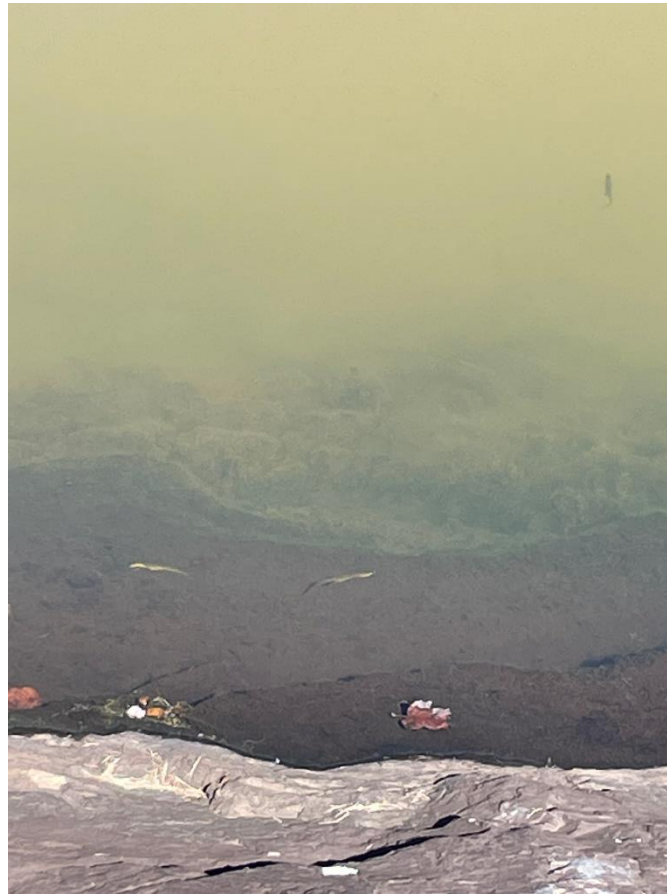
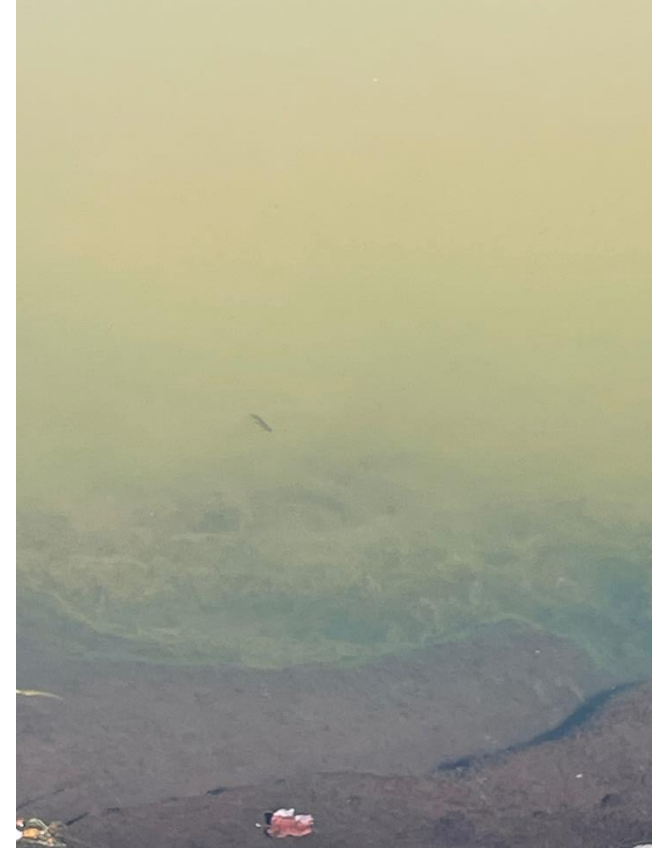
Water exits the lake through the discharge area.  
The banks are protected by rip rap that decrease erosion.  
This year, there were salamanders in the water!

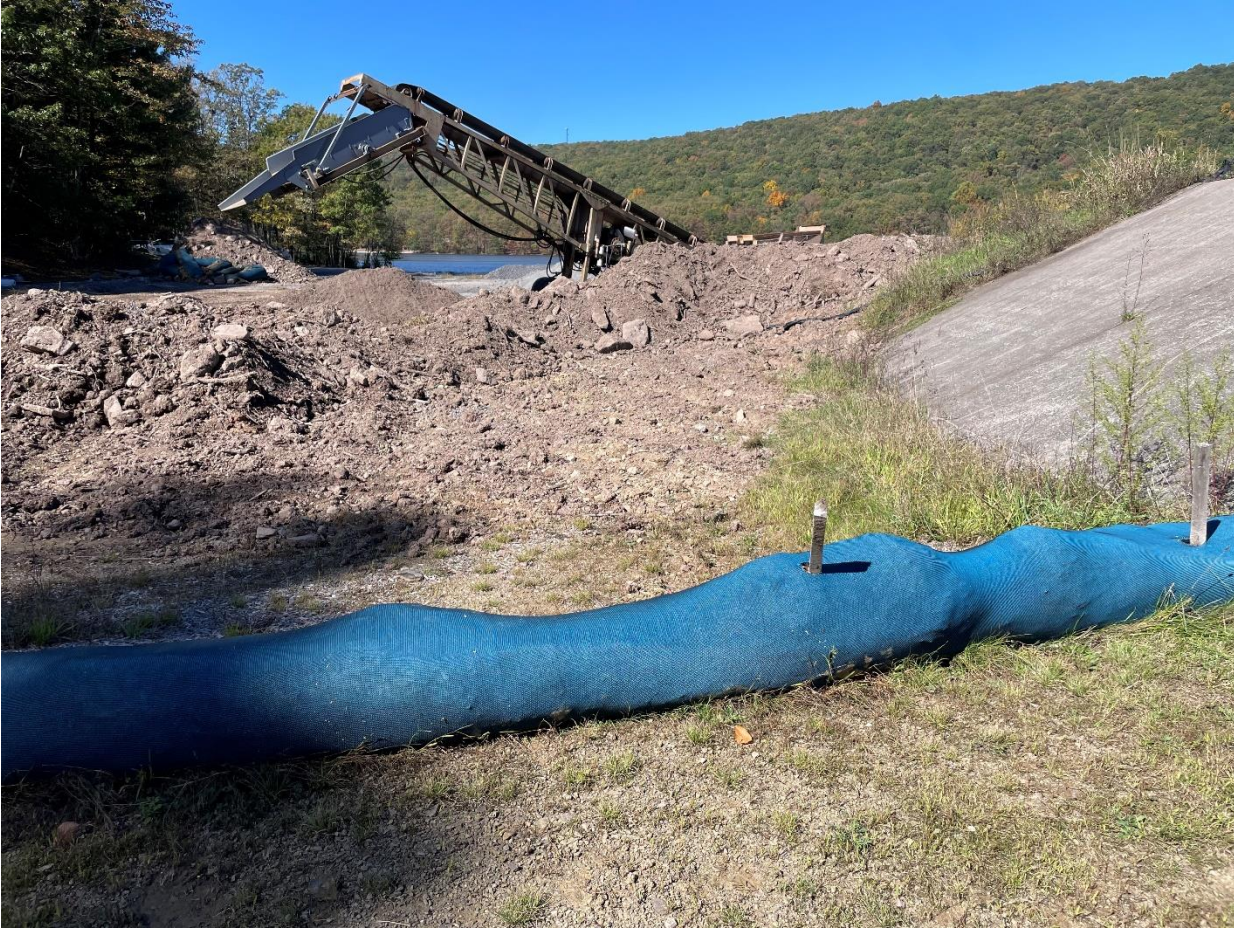
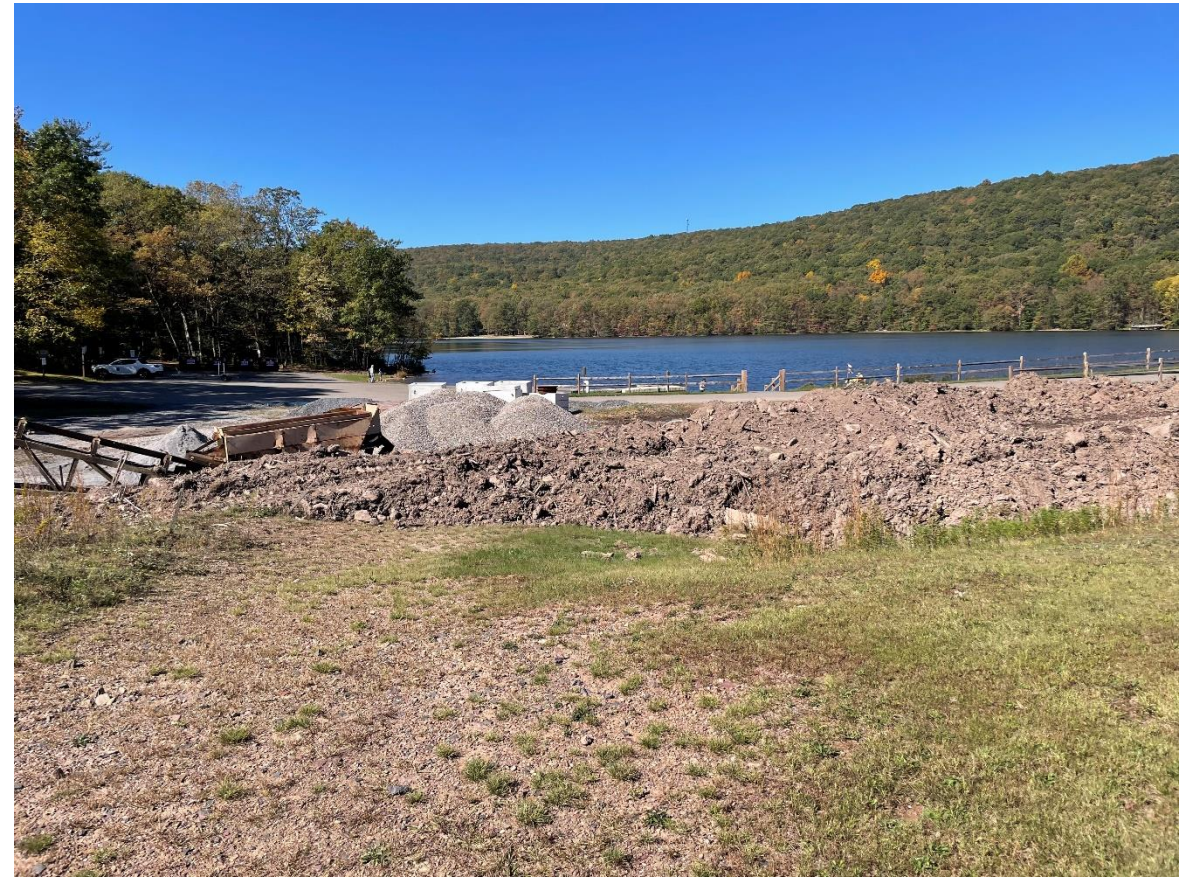
The spillway had some adjustment occurring

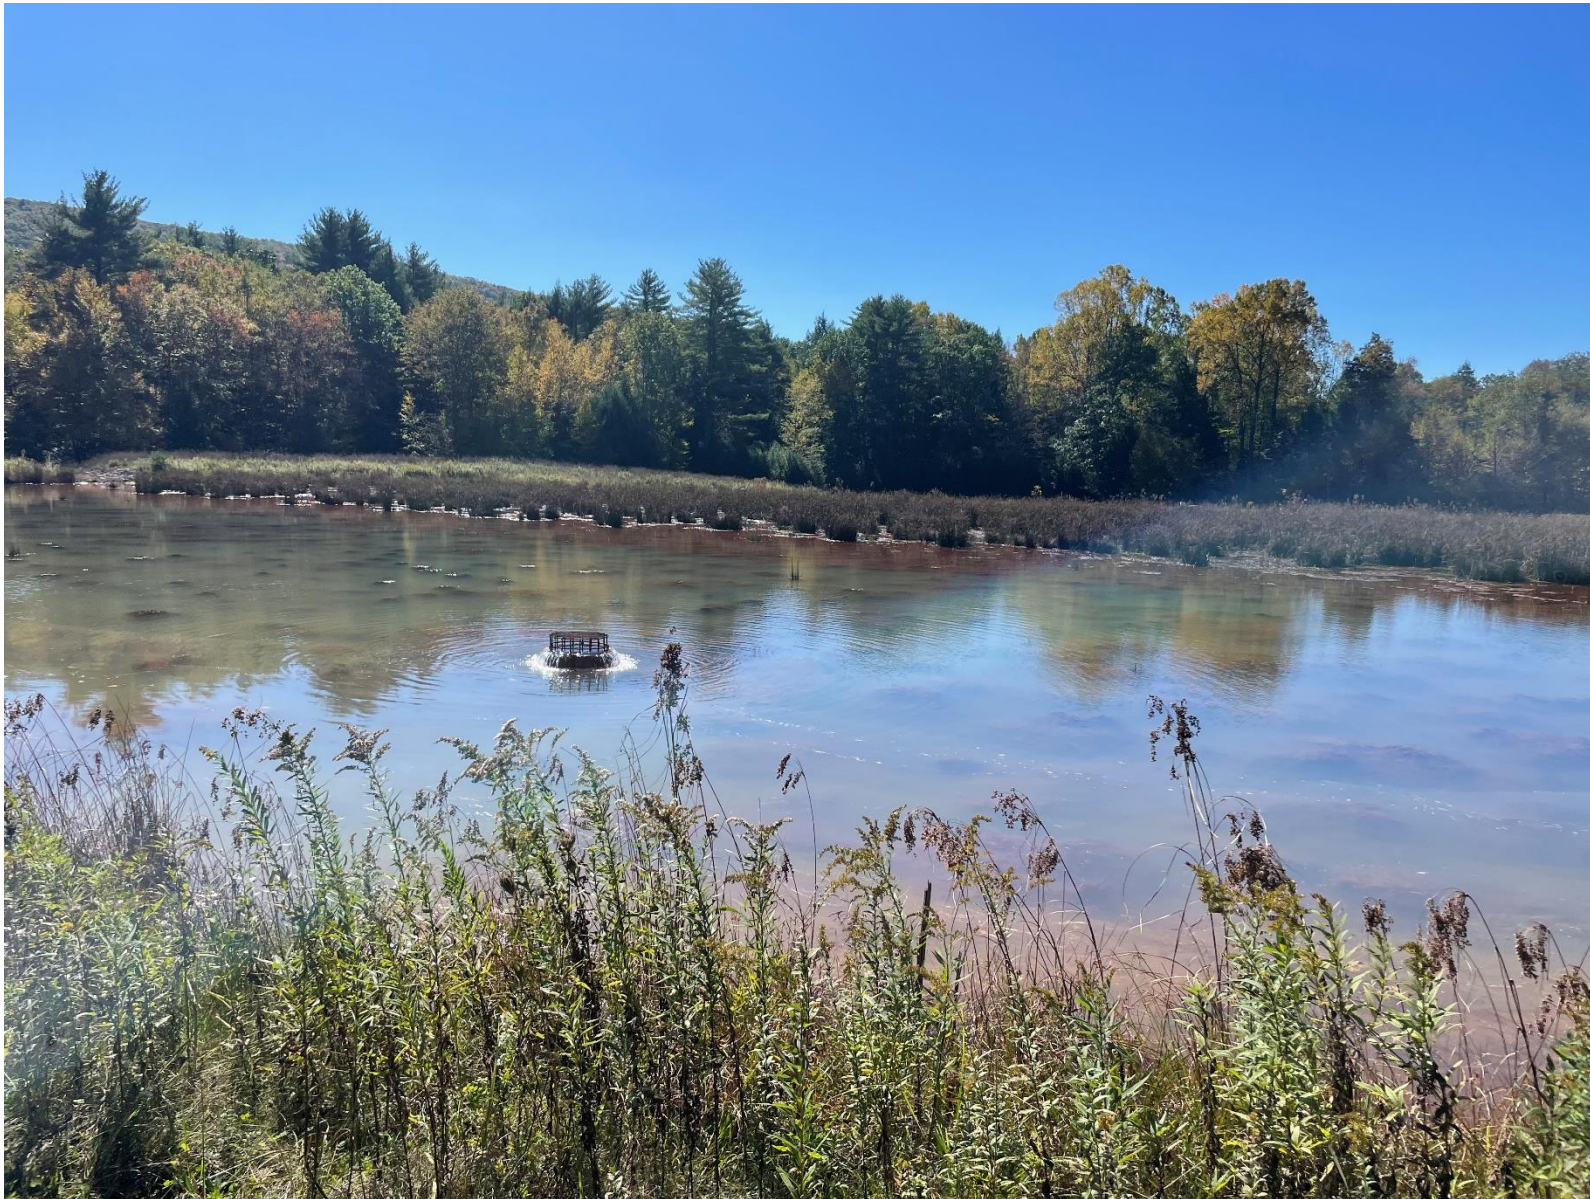
The Schuylkill Conservation District and the Schuylkill Headwaters Association work toward a cleaner watershed through passive remediation projects such as this wetlands at Mary-D. Abandoned Mine Drainage (AMD) enters the system with low pH and high iron levels. The water is passed over limestone to increase the pH. There are a series of pools in which the iron can oxidize and precipitate out of the AMD

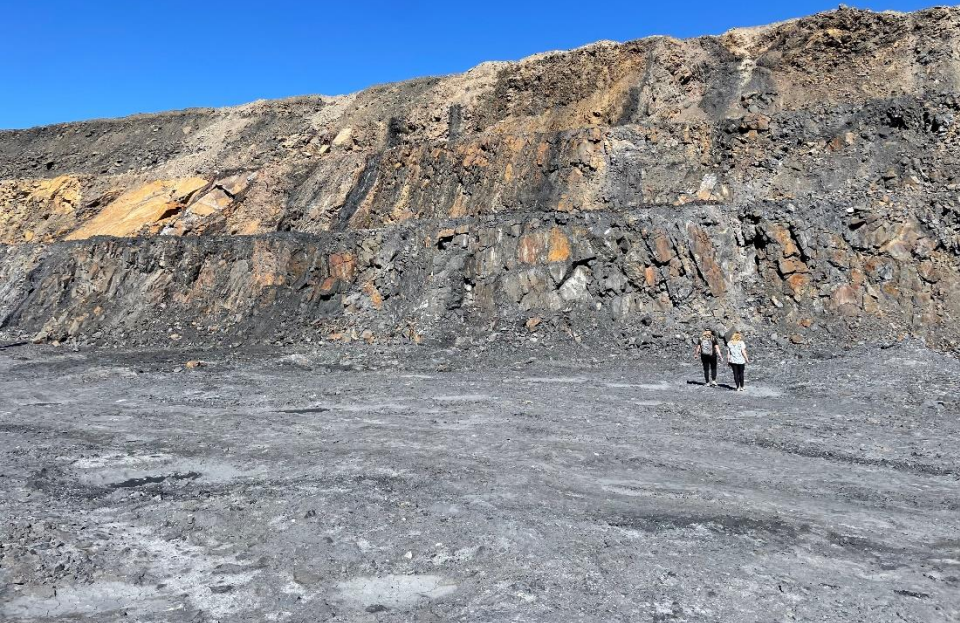
Springdale pit, with coal seams running nearly vertical through the rock formations

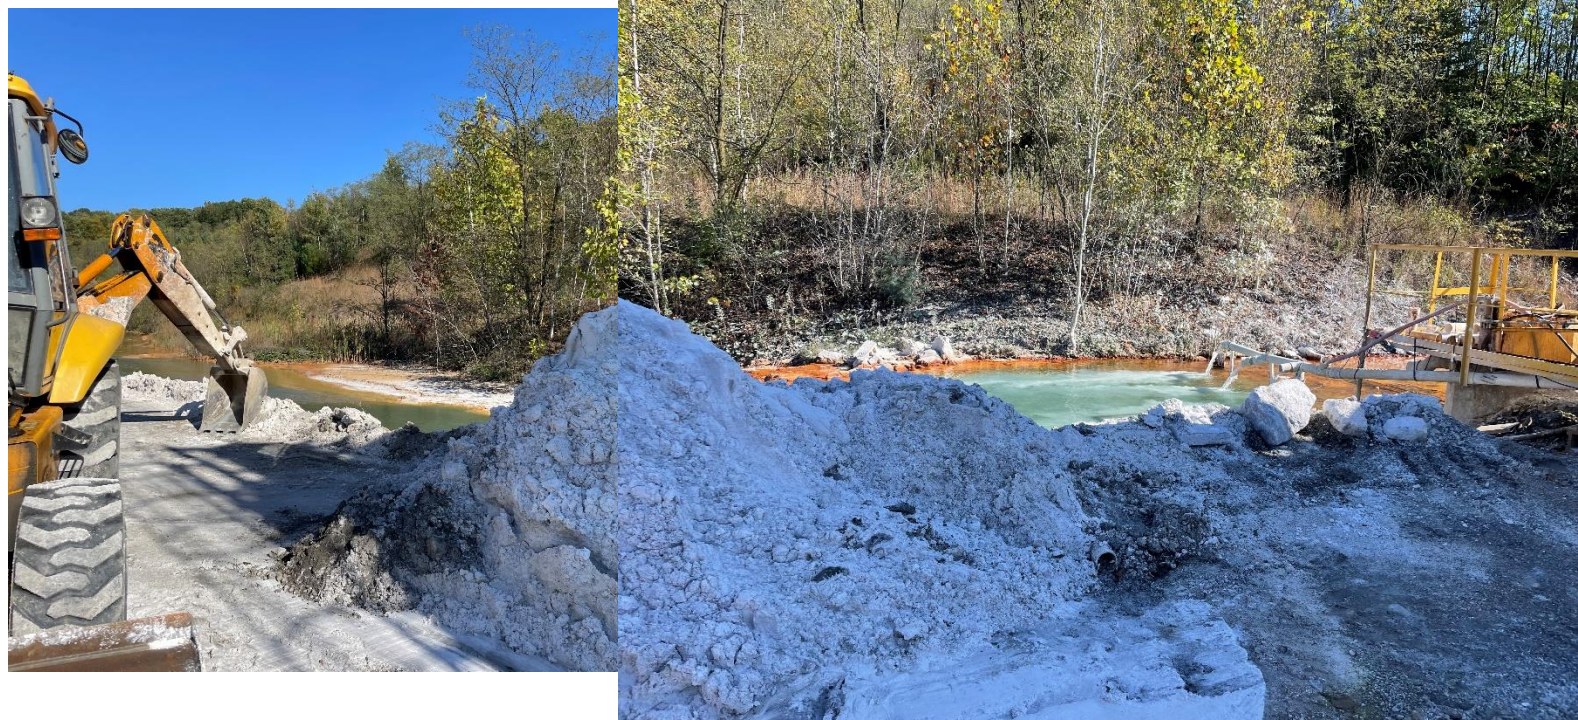
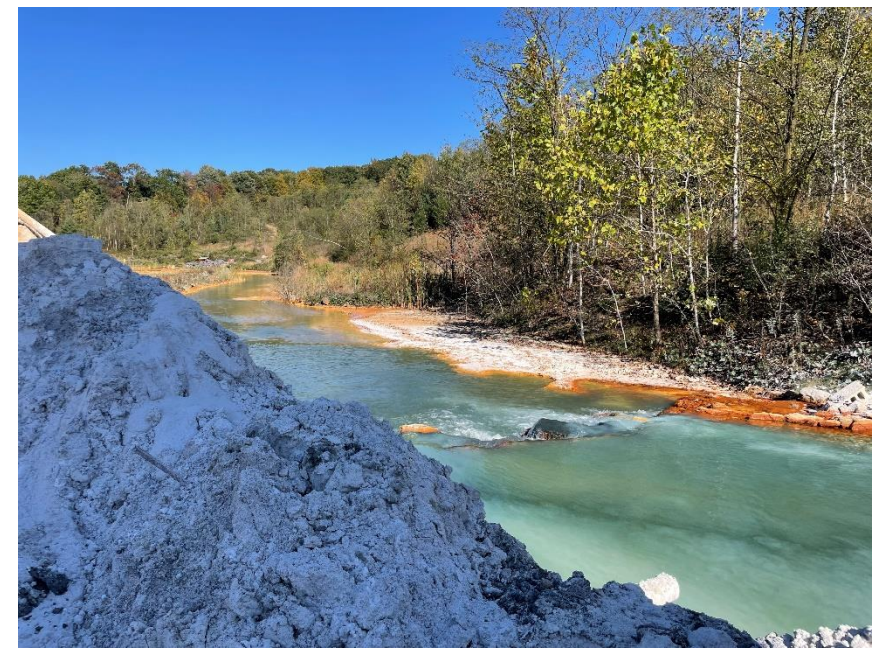
The 309 Discharge is a site of active remediation where the water is being treated to increase the pH and remove iron prior to discharge into the Little Schuylkill River. Following the active treatment, the water flows through a wetland area where iron precipitates prior to entering the Little Schuylkill River.
