The headwaters of the Schuylkill Watershed – This region is severely impacted by its long mining history. Water has been shifted and moved by many generations of miners, and the subsurface is fractured by the mining process. Water that enters the subsurface mine pools becomes contaminated with sulfuric acid and iron from pyrite oxidation. The Schuylkill Conservation District and the Schuylkill Headwaters Association are making efforts to clean up the region through passive remediation projects.

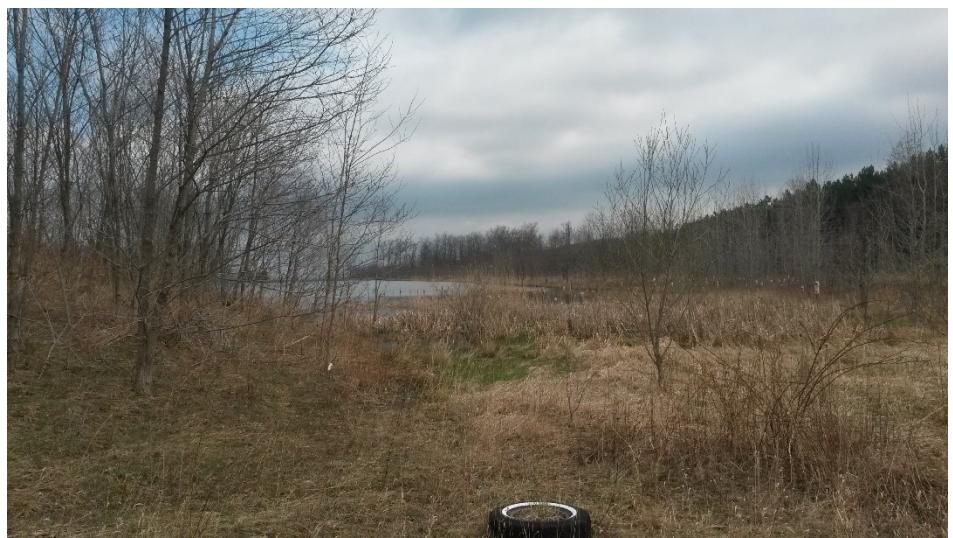
Another stop in the headwaters . . . This region has been extensively mined, as apparent from the overburden on either side of the valley. Coal waste had been exiting this valley during times of intense rainfall and turning waters downstream black. The Headwaters Association obtained funds to stop this pollution.

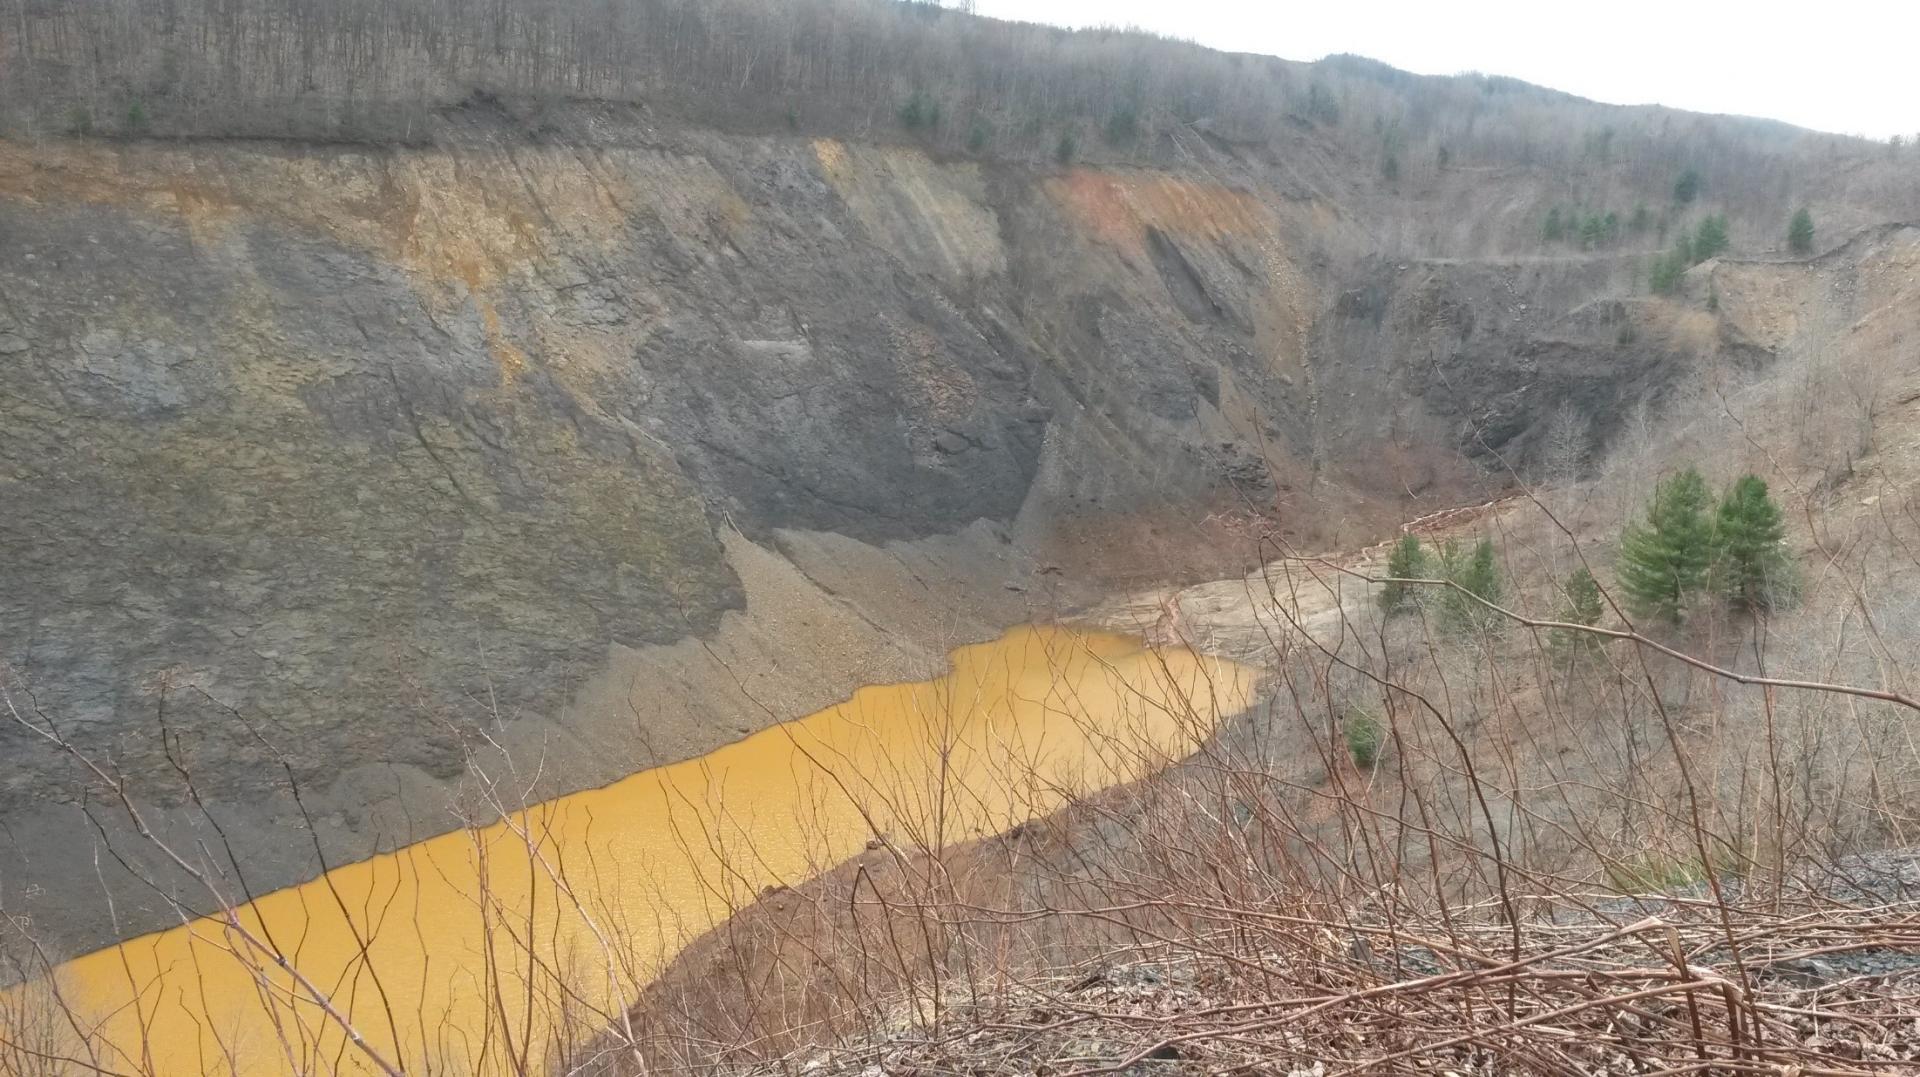
At The Potato Patch (the former location of an Irish community) surface water drains to the old strip mine and is held there until it seeps into the subsurface mine pool. This water becomes contaminated with iron as is apparent by the orange color of the pool within the stripping pit.

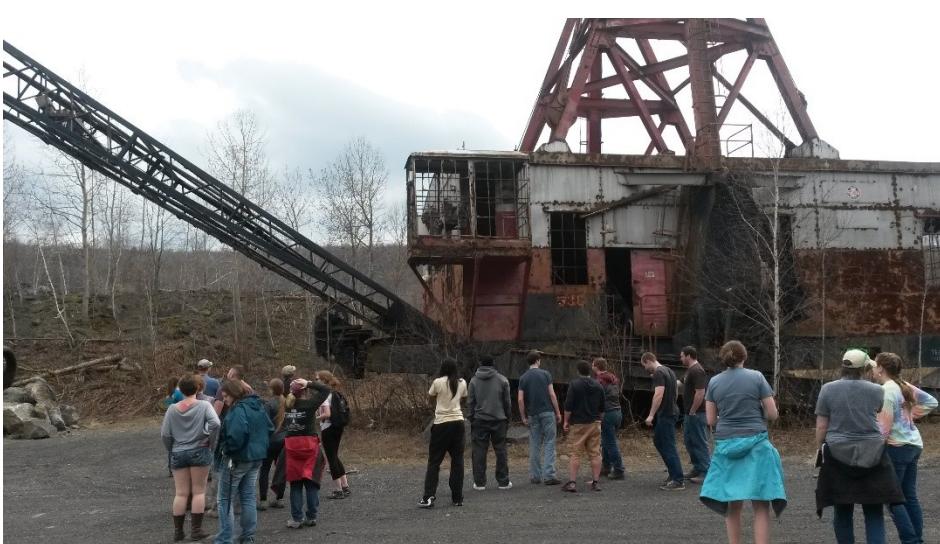
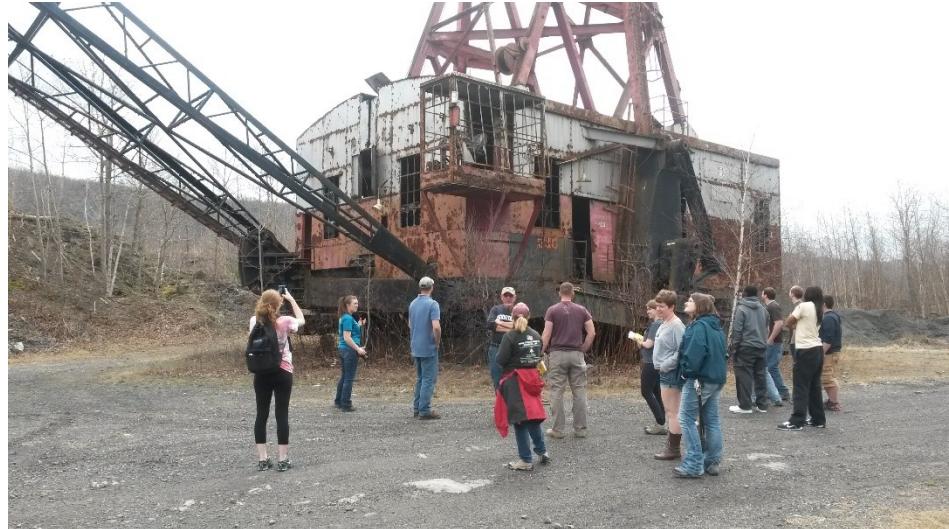
The old drag line has been abandoned here. It was built in the Midwest, walked to PA, and spent many years as the workhorse of this coal mine. This equipment is operated by only two men, taking the place of many mine workers in the mining practices of the last century.

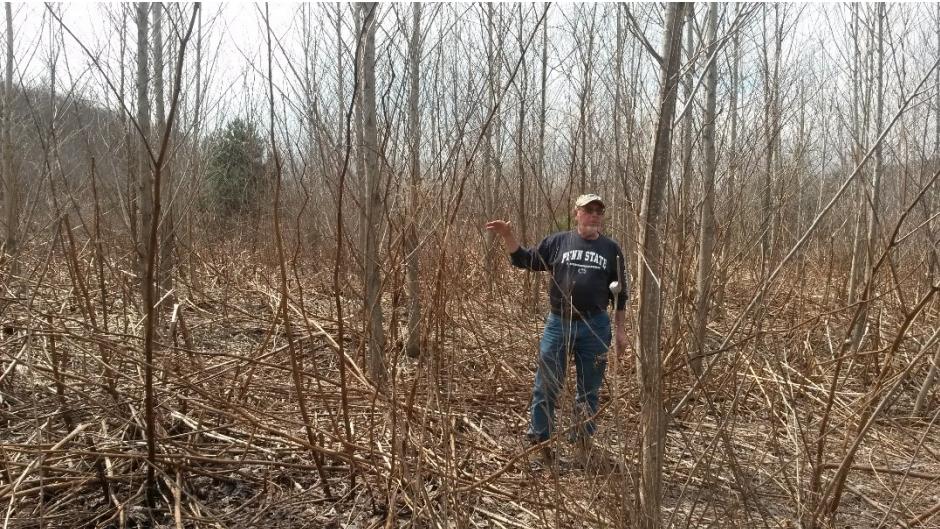
The poplars grown here in the reclaimed strip mine are flourishing because of biosolid application. There is currently a limit of 60 tons per acre on biosolids, even within reclaimed strip mines.

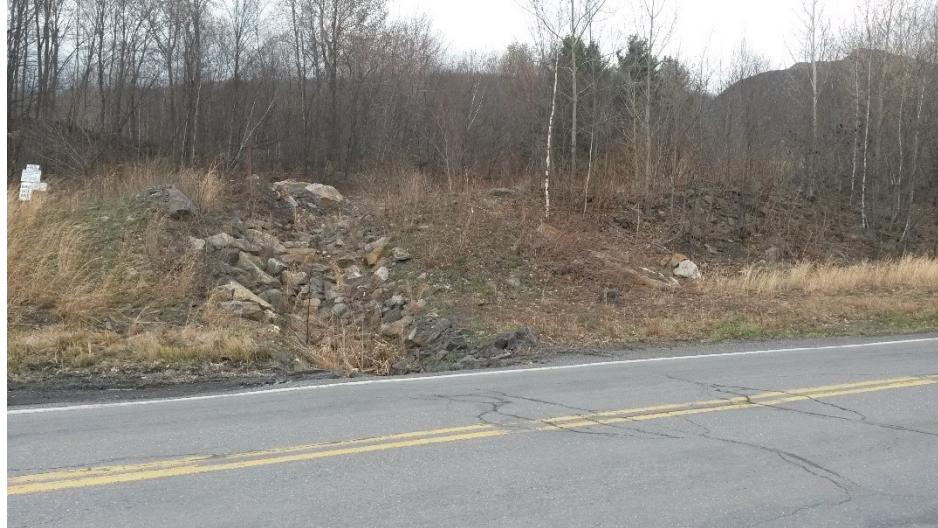
The strip mine across the street has been open a total of four times as economic changes made coal extraction feasible.

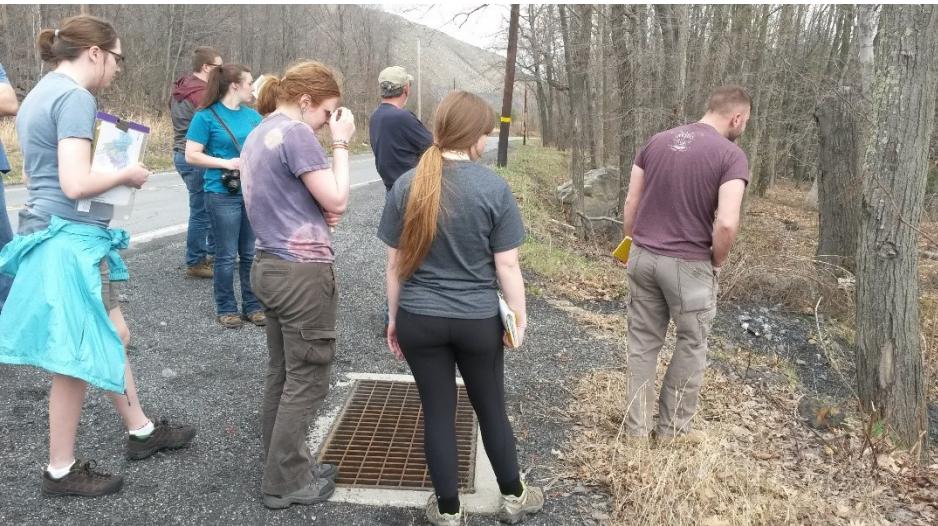
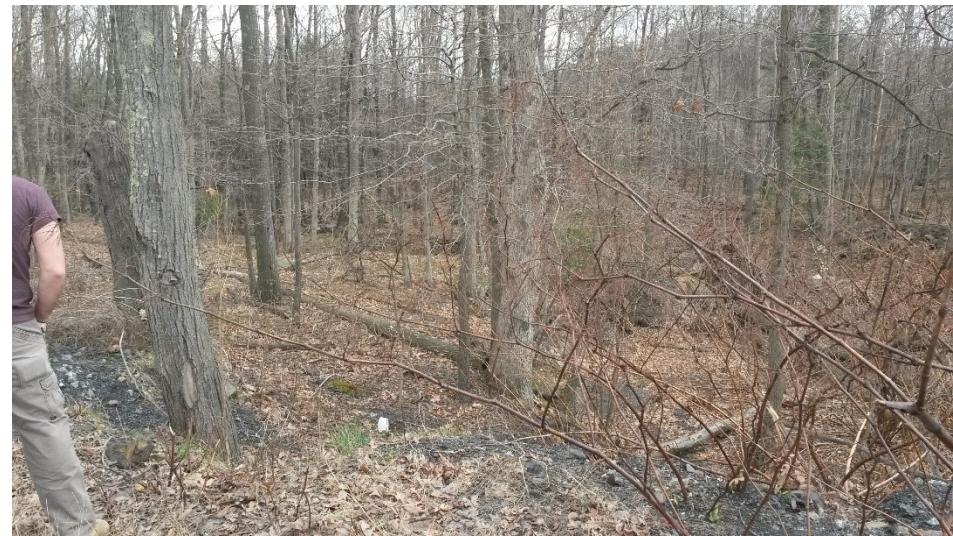
Crop fall (below) was a location of a DOT drainage. Instead of allowing the water to sit in the crop fall and seep into the mine pool, Bill rerouted the discharge to the stream channel.

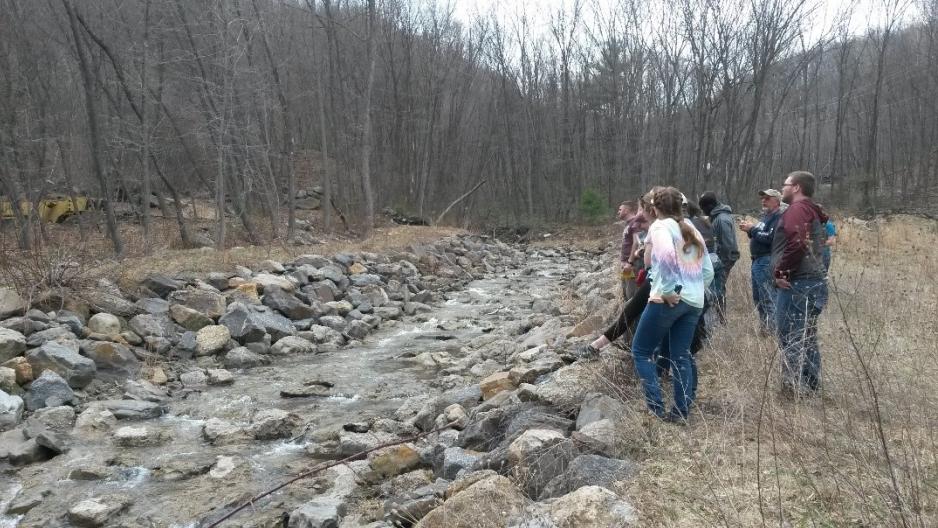
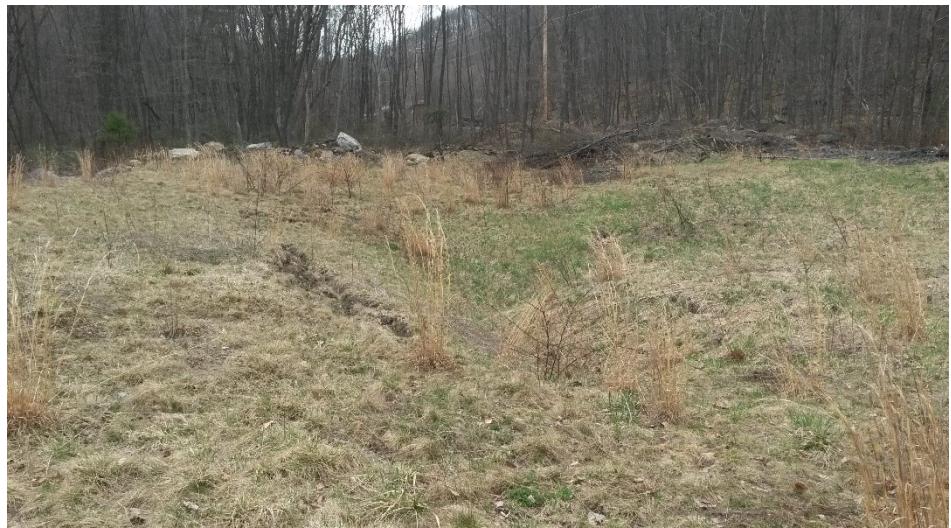
Wheeler Run – This stream channel used to have a flume which kept the water from entering the subsurface mine pool. However, the flume was in a state of disrepair. The Schuylkill Headwaters Association removed the flume and lined the stream channel with an impermeable barrier. Due to the high flows that are experienced in this area, they also had to coat the rocks in the stream channel with cement to hold them in place. Over time the cement will weather away and be replaced with natural sediments.

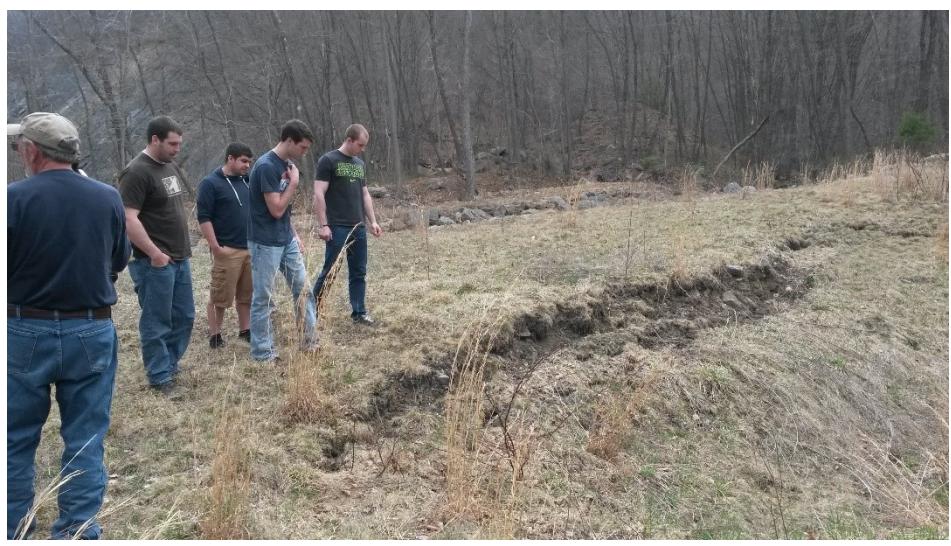
Since the stream channel work, a crop fall has started to develop beside the stream. This crop fall has become deeper over the past year (see pictures from 2014 field trip).
