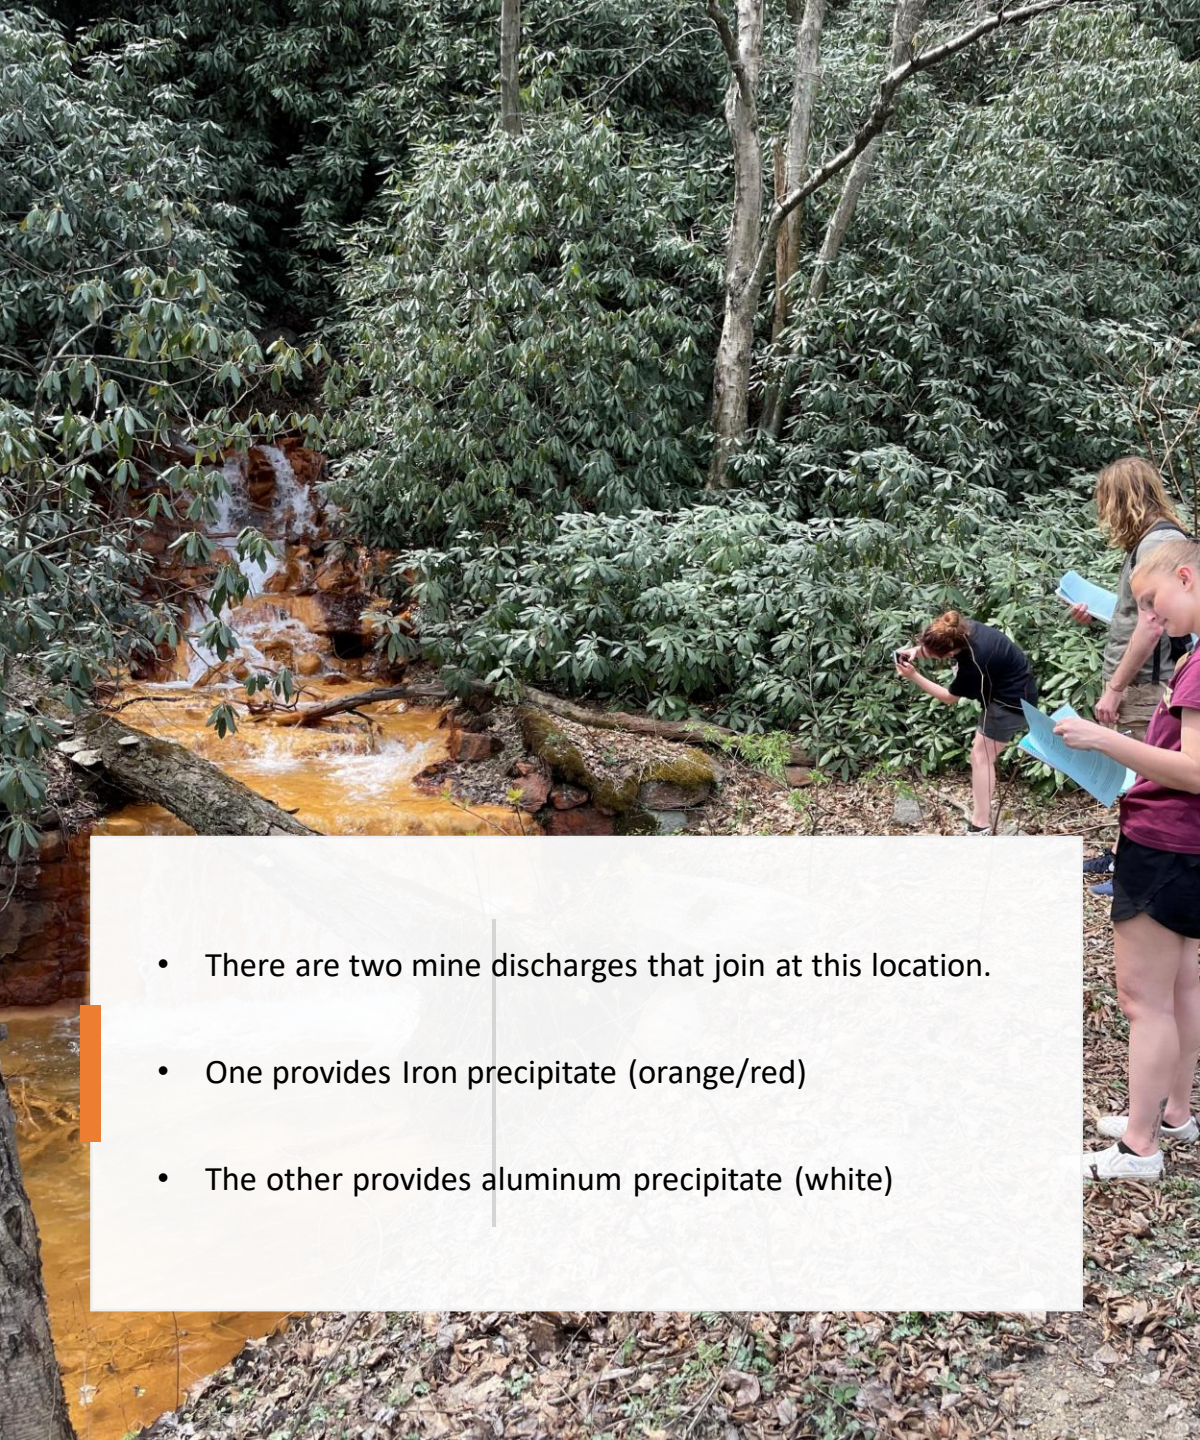
- There are two mine discharges that join at this location.
- One provides Iron precipitate (orange/red)
- The other provides aluminum precipitate (white)

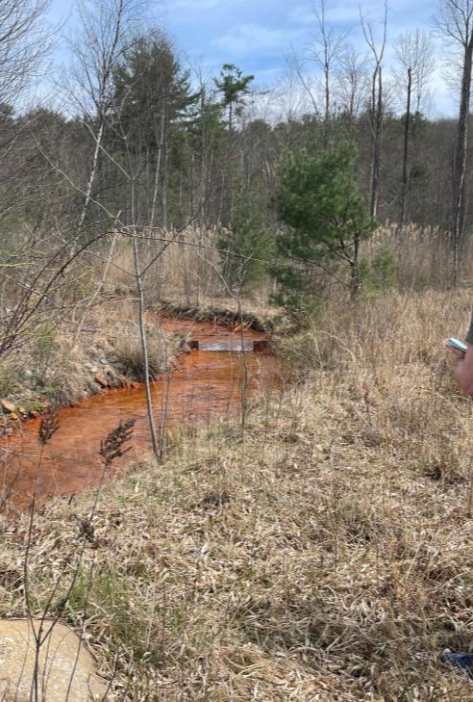
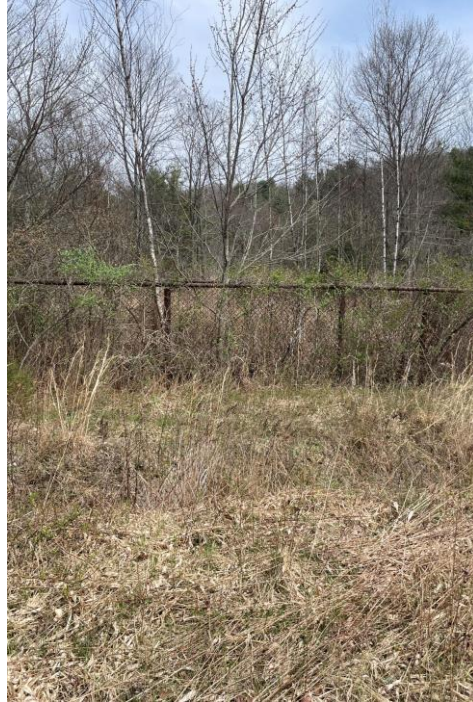
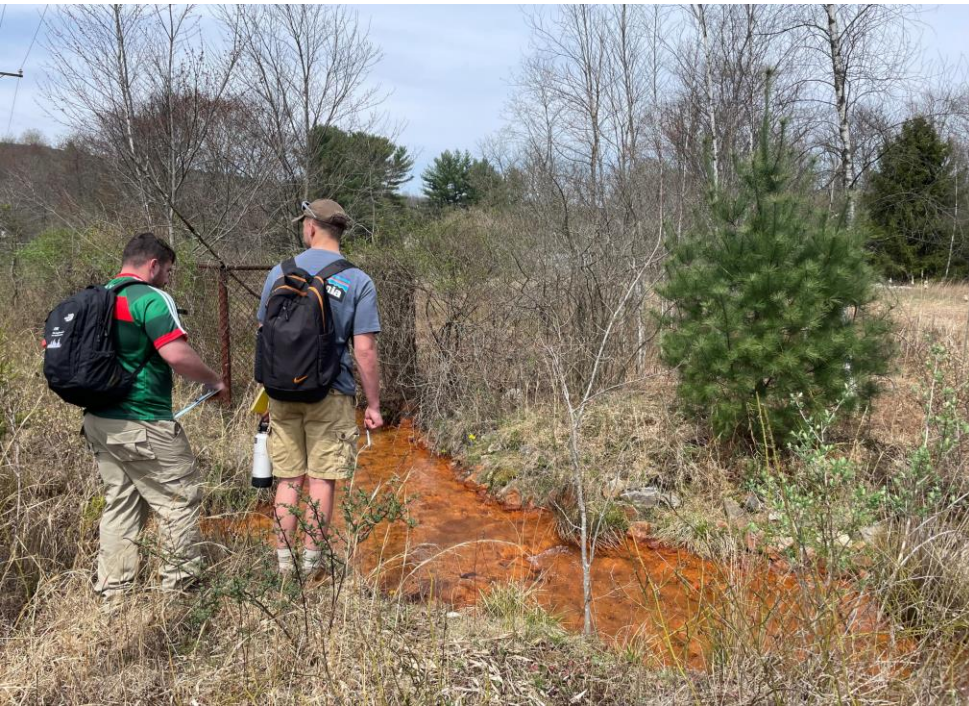
- Water discharges from subsurface mines at this location.
- The discharge area frequently floods during high rains, thus making the area impractical for passive treatment of the water.
- 
- This water discharges into the West Branch of the Schuylkill River.
- Monitored by USGS

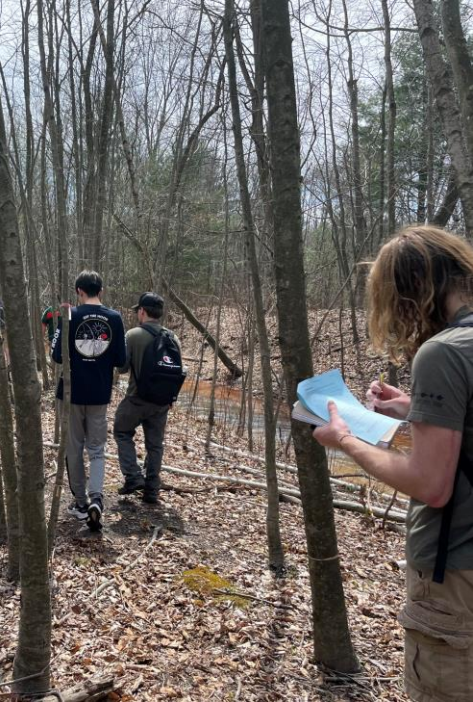
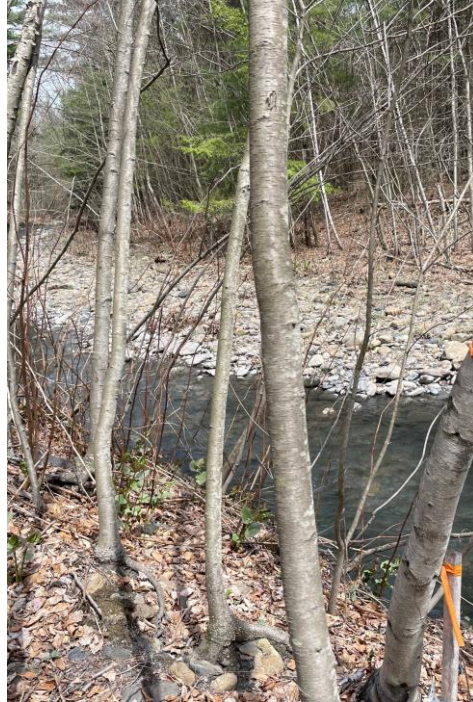
- This is the convergence of the West Branch of the Schuylkill River and the Pine Knot Discharge.

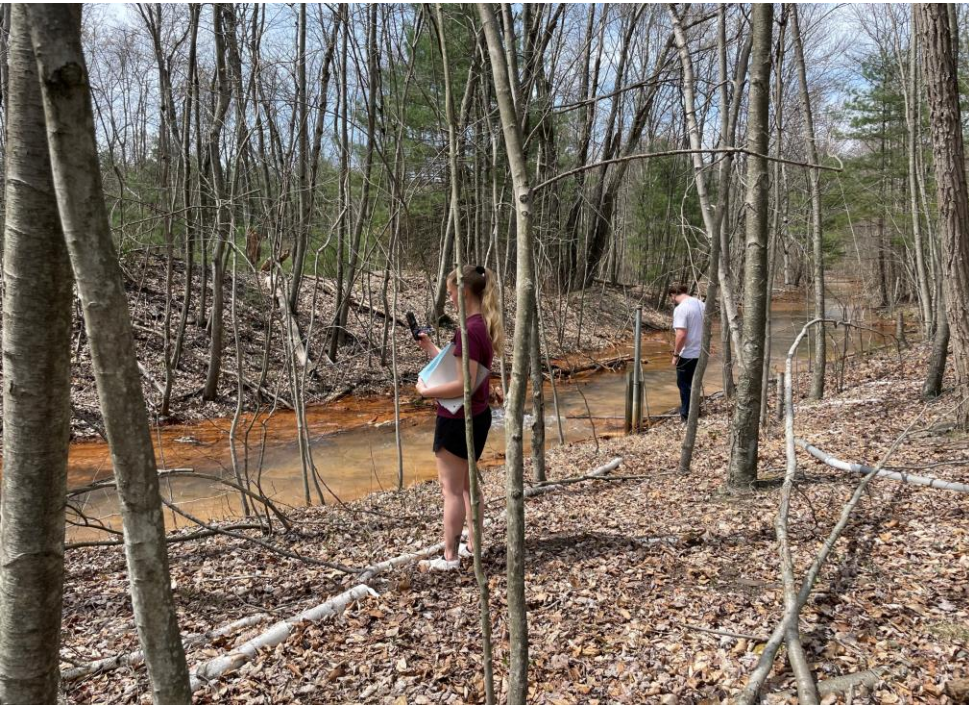
- The West Branch sometimes is dry, but the Pine Knot Discharge never dries up.

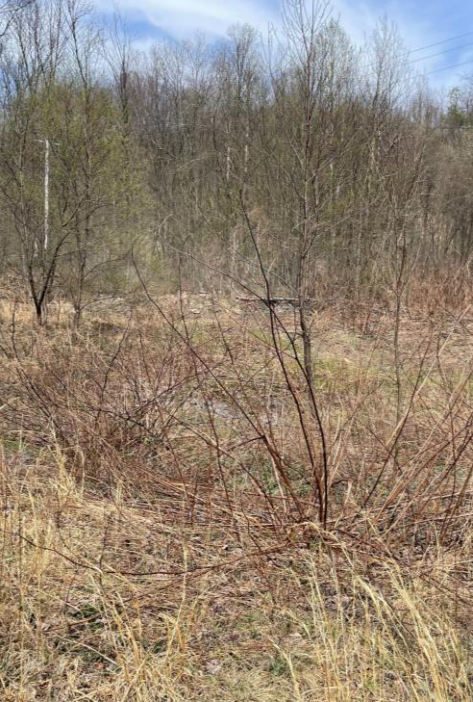
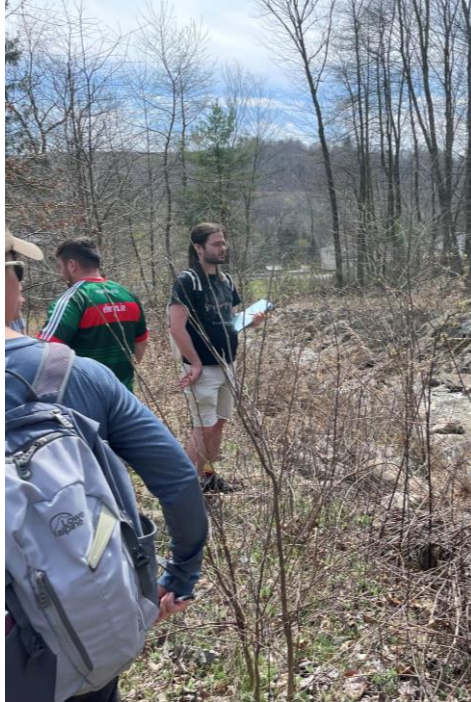
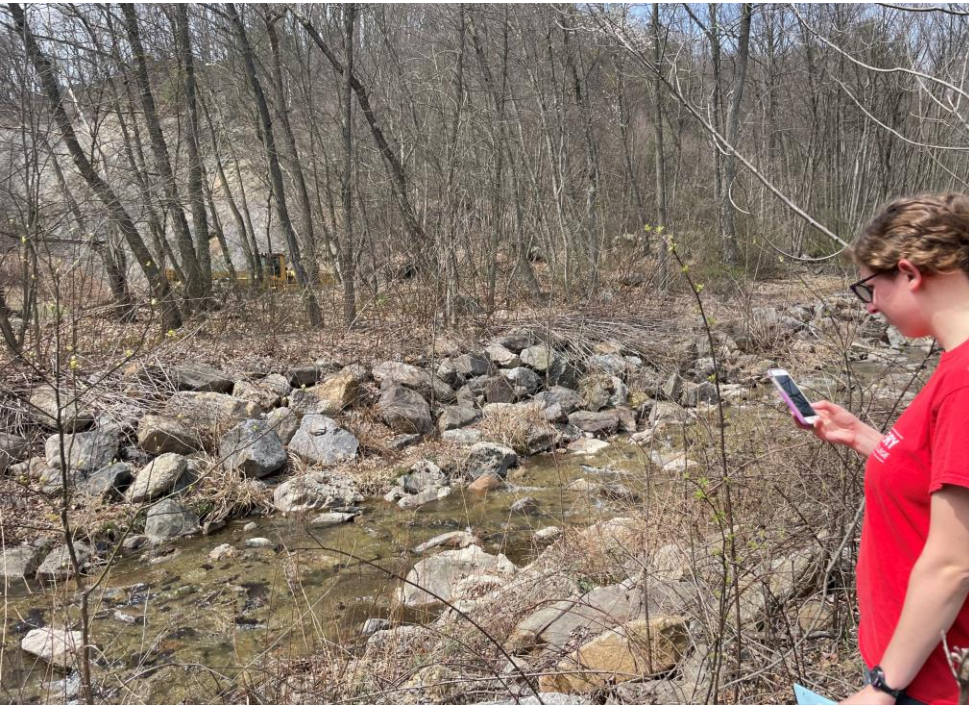
- This stream channel used to have a flume which kept the water from entering the subsurface mine pool.
- 
- The Schuylkill Headwaters Association removed the flume and lined the stream channel with an impermeable barrier.
- Due to the high flows that are experienced in this area, they also had to coat the rocks in the stream channel with cement to hold them in place. Over time the cement will weather away and be replaced with natural sediments.
- Since the stream channel work, a crop fall has started to develop beside the stream.

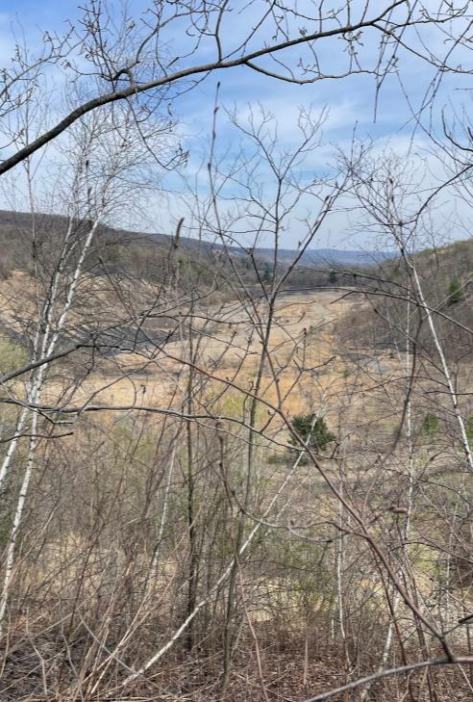
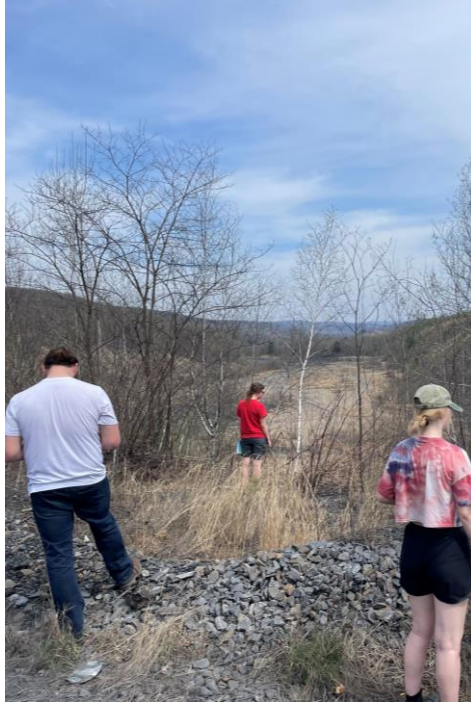
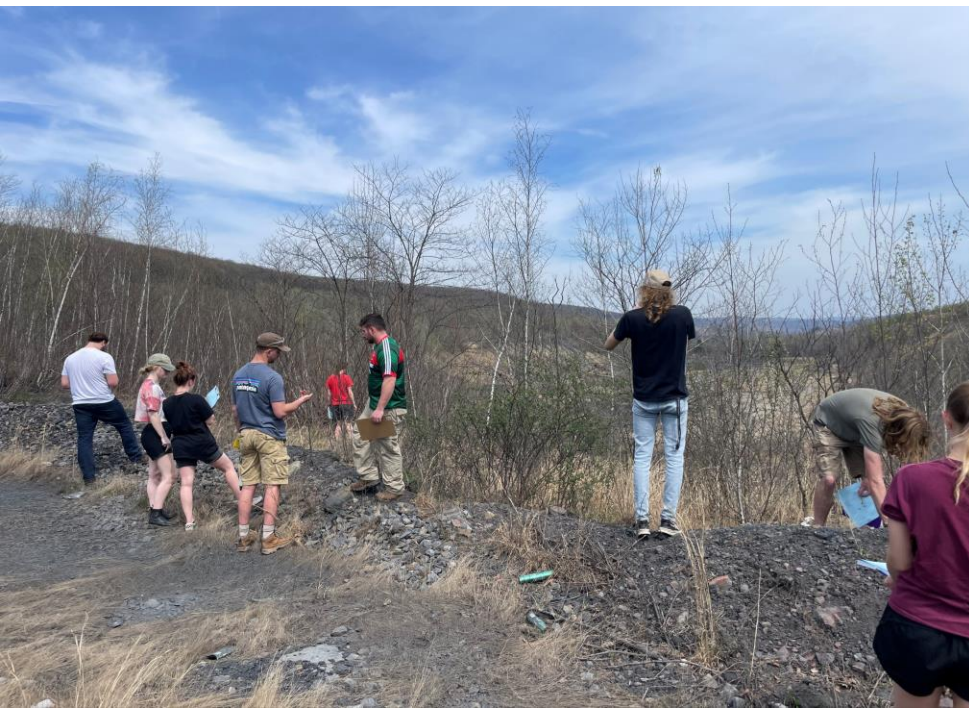
- This region has been extensively mined, as apparent from the overburden on either side of the valley.
- 
- Coal waste had been exiting this valley during times of intense rainfall and turning waters downstream black.
- The Headwaters Association obtained funds to stop this pollution.

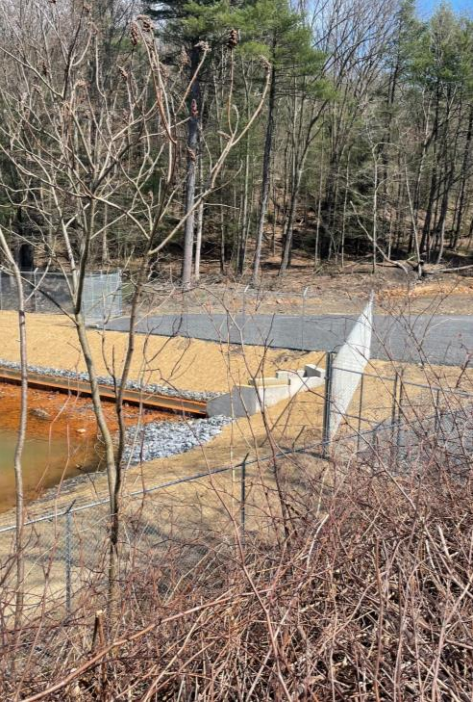
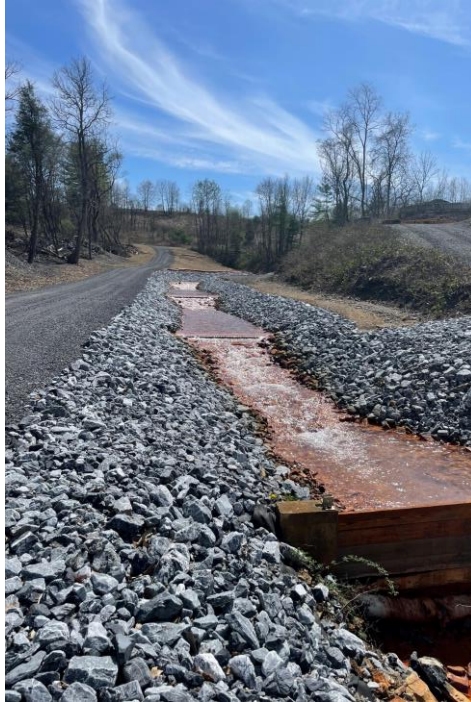
- The Otto remediation site in Reilly Township has a depth of 12 feet for iron collection but needs more time for precipitation to occur.

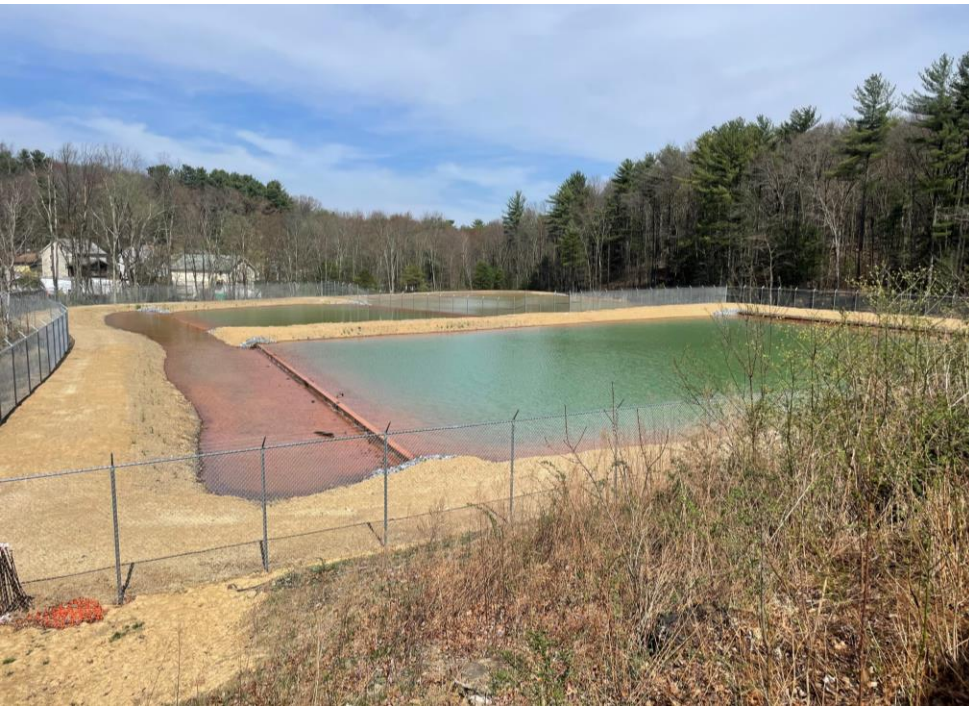
- A longer path to the wetlands to allow for increased oxygenation was recently incorporated
- This site channels 10,000 gpm of water at a pH near 6 through a settling/aeration pond (to remove the iron and the carbon dioxide).
